Scrapped Pump Brought Back to Life with Belzona

ID: 9743

Application: CEP-Centrifugal Pumps

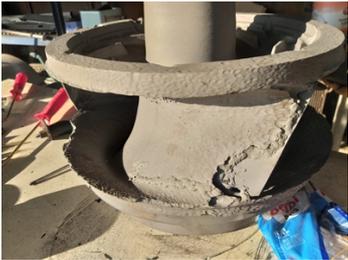
Surface losses resulting from erosion experienced in the impeller of the sludge pump used in the wastewater treatment plant.

Before application

Application was carried out in accordance with Belzona Know-How System Leaflets CEP-3 & CEP-5.

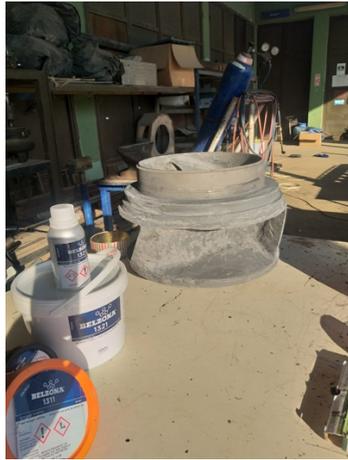
Before application

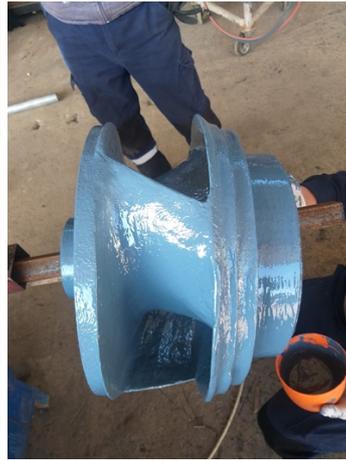
After application

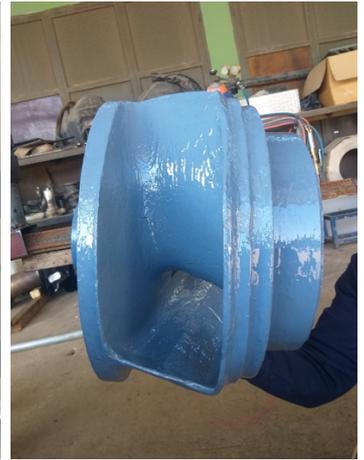
After application
