Anchor Handling Tug in need of critical piping repair

ID: 9744

Industry: *Marine*
Application: *VPF-Valves, Pipes and Fittings*
Substrate: *Carbon steel*
Products: *Belzona 1212, Belzona 9611 (ES-Metal)*

Customer Location: *Angola offshore*
Application Date: *January 2025*

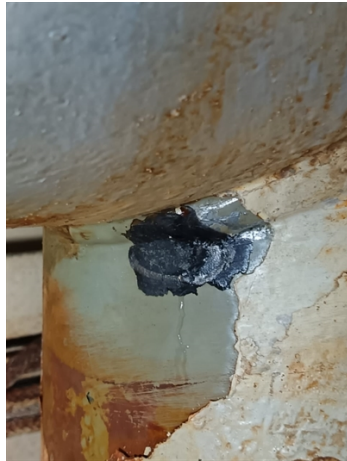
Surface preparation to SSPC-SP11 by means of Bristle Blaster power tools.

Surfaces were prepared to bare steel with a profile using Bristle Blasters, achieving SSPC-SP11 cleanliness standard.

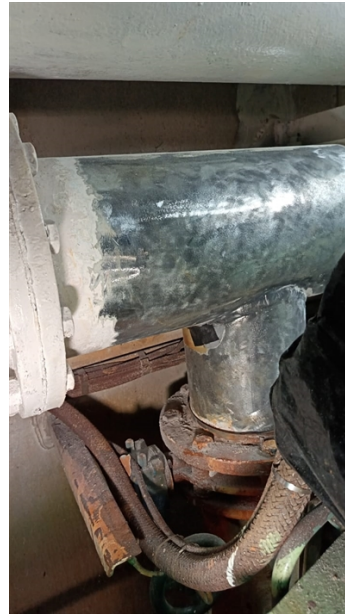
Repair extended to reinforce the suspected thin wall condition of the pipe spool.

The through wall defect was stopped by the application of Belzona 9611.

Belzona 1212 was then applied onto Belzona 9341 Reinforcing Sheet, and applied to the surfaces of the pipe to reinforce and strengthen the suspected surrounding thin wall pipe. A second layer of Belzona 1212 was then applied for additional reinforcement.
