BELZONA REPAIRS EBONITE COVERED CARPET ROLL

ID: 975

Customer Location: Carpet manufacturer, Kidderminster, UK
Application Date: June 2008

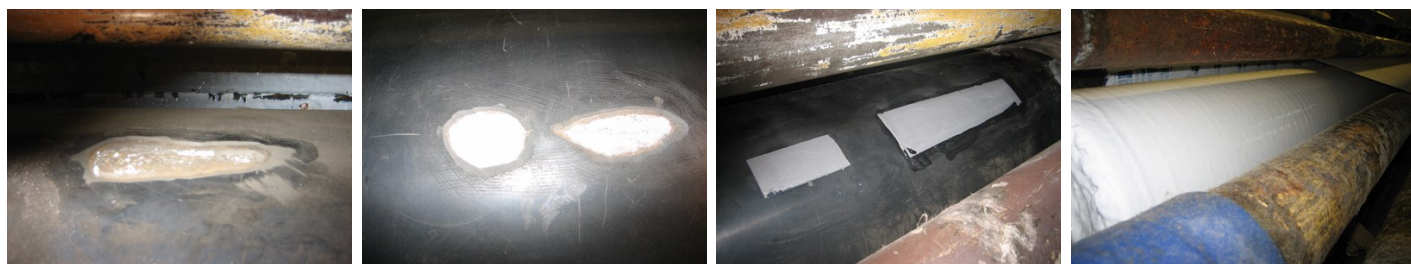
Photograph Descriptions

The ebonite had suffered from localised wear and was not readily repairable. In fact the original manufacturer did not recomend repair of this material

- * Roll showing area of missing Ebonite ,
- * Two damaged areas, the left side prepared the right yet to be prepared ,
- * The two areas brought back to profile with Belzona® 1111 ,
- * The Latex Applicator back in action ,

Application was carried out in accordance with a modified version of Belzona Know-How System TCC-3. Ebonite was cut back to a sound edge and after roughening exposed steel and surrounding Ebonite, Belzona® 1111 was applied and then finished to profile using sa template cut from a Belzona Mixing Board.
