Flange Face Rebuilding with Belzona 1111

ID: 9750

Industry: Oil & Gas
Application: VPF-Valves, Pipes and Fittings
Substrate: Carbon steel
Products: Belzona 1111 (Super Metal), Belzona 9411 (Release Agent)

Customer Location: Dammam, Saudi Arabia
Application Date: January 2025

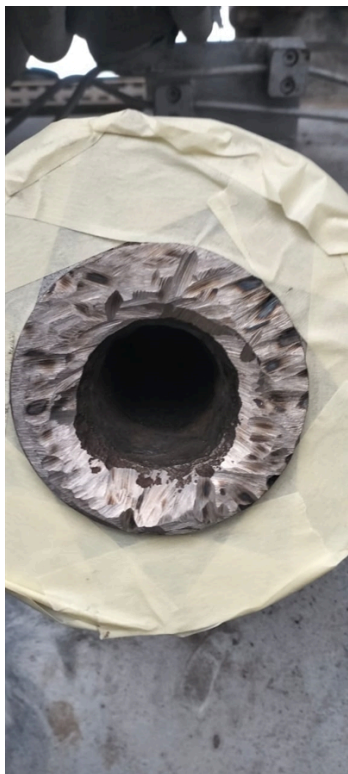
The customer was face loss of metal due to wear over the flange face

Surface preparation is done over the flange face before the rebuilding

We used power tools for surface preparation, and we roughened the surface to create an anchor for the Belzona 1111; we formed a former of 2 and 3 inch , used Belzona release agent and applied the Belzona 1111 over the flanges

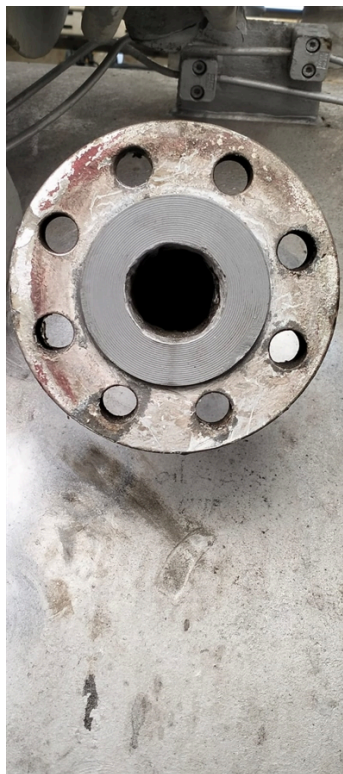
Final stage after rebuilding using a former

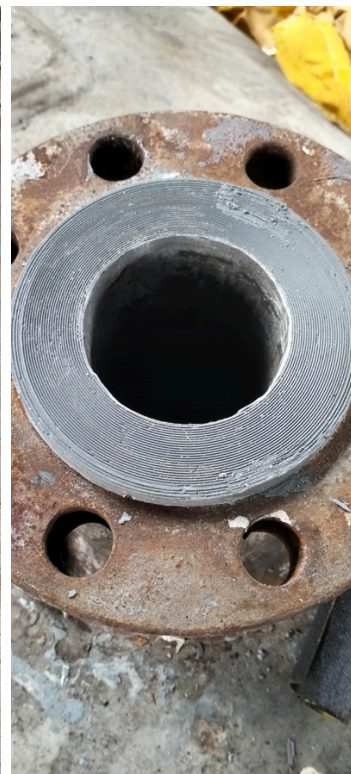
After the former removal, the final stage of rebuilding
