Flange Face Rebuilding with Belzona 1111

ID: 9750

Industry: Oil & Gas
Application: VPF-Valves, Pipes and Fittings
Substrate: Carbon steel
Products: Belzona 1111 (Super Metal), Belzona 9411 (Release Agent)

Customer Location: Dammam, Saudi Arabia
Application Date: January 2025

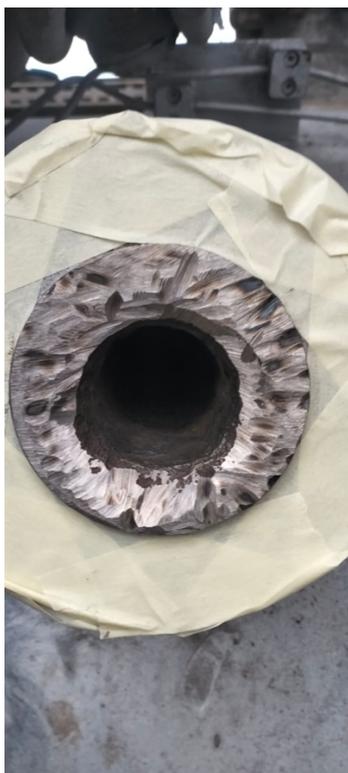
The customer was face loss of metal due to wear over the flange face

Surface preparation is done over the flange face before the rebuilding

We used power tools for surface preparation, and we roughened the surface to create an anchor for the Belzona 1111; we formed a former of 2 and 3 inch , used Belzona release agent and applied the Belzona 1111 over the flanges

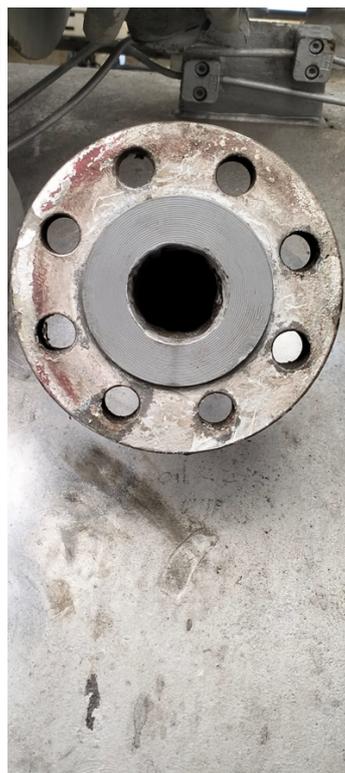
Surface preparation with power tools to prepare the surface

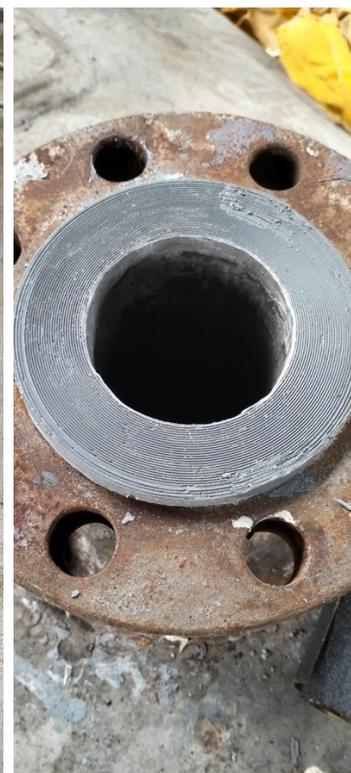
Final stage after rebuilding using a former

After the former removal, the final stage of rebuilding
