# Belzona Repairs Split Case Pump

Industry: Water / Wastewater  
Application: CEP-Centrifugal Pumps  
Substrate: Cast Iron  
Products: Belzona 1341 (Supermetalgilde)

Customer Location: Melbourne Australia  
Application Date: January 2025

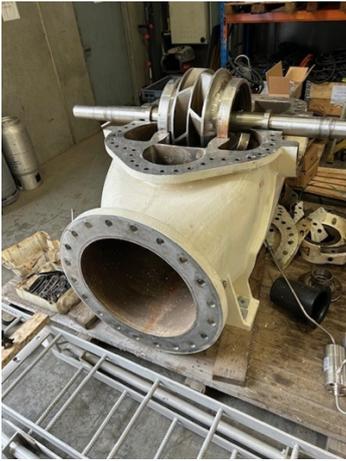
Split case pump prior to application.

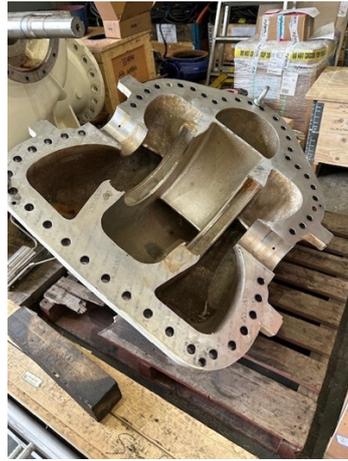
Internal split case pump prior to application

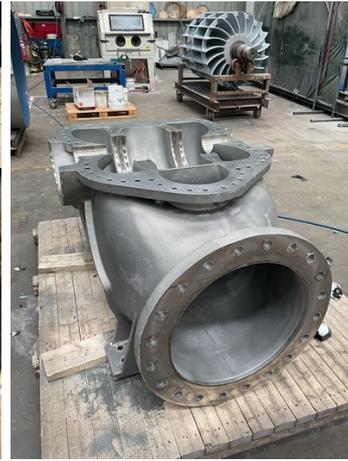
Pump casing abrasive blasted, ready for Belzona coating.

Pump was received into our workshop. Surface prep and clean carried out and an internal coating using Belzona 1341 (Supermetalgilde). External of the pump was coated in a 2 pac paint as per customers specification.
