BELZONA SOLUTION FOR REFURBISHMENT OF PUMP CASINGS

ID: 9755

Application: CEP-Centrifugal Pumps

Customer Location: ABU DHABI, UNITED ARAB EMIRATES

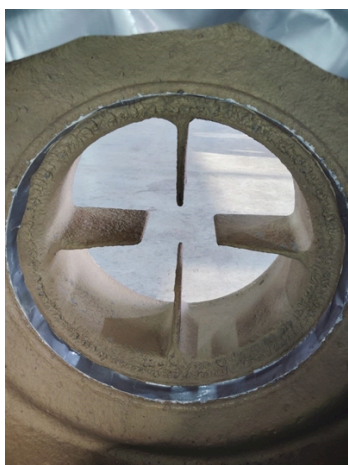
A power station customer is experiencing severe corrosion and material loss in their potable water centrifugal pumps, which are critical for water displacement circulation. This deterioration is driving up maintenance costs, reducing efficiency, and causing unexpected downtime. To restore performance and ensure long-term reliability, the customer requires a durable solution to mitigate corrosion and extend the equipment's service life.

Severe corrosion and material loss in centrifugal pumps.

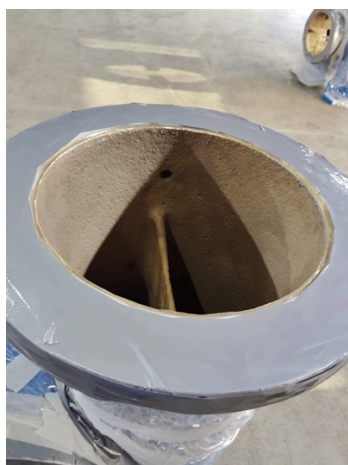
Surface was grit blasted to achieve the required profile.

1. After thorough cleaning, the surface was grit blasted to achieve the required profile.
2. Damaged areas were repaired with Belzona 1121 (Super XL-Metal) for a strong, long-lasting restoration.
3. Finally, the surface was coated with 2 coats of Belzona 1341 (Supermetalglide), strictly adhering to the manufacturer's Instructions for Use (IFU) to ensure maximum protection and performance.

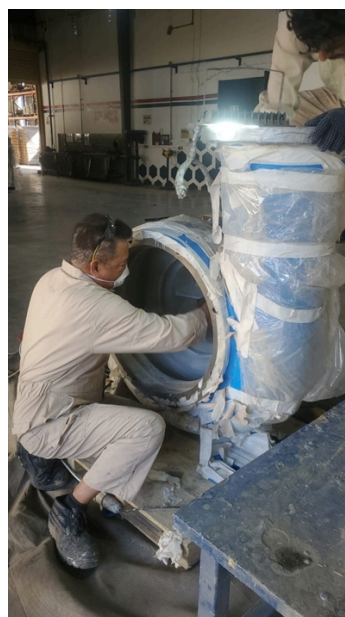
Application of Belzona 1121 for a strong, long-lasting restoration.

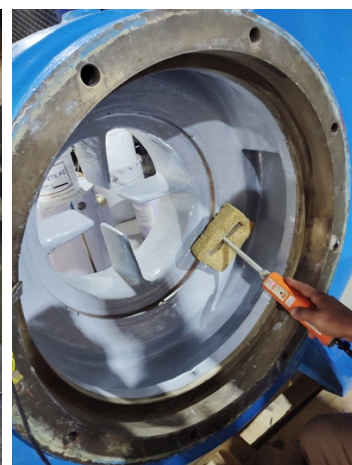
The surface was coated with 2 coats of Belzona 1341.
