Belzona Chocking System Installed at a Papermill

ID: 9758

Industry: *Pulp & Paper*
Application: *GSS-Gaskets, Seals and Shims*
Substrate: *Concrete*
Products: *Belzona 7111, Belzona 9411 (Release Agent)*

Customer Location: *NSW Australian*
Application Date: *October 2022*

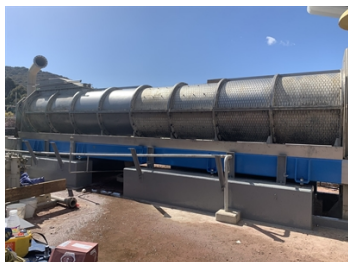
Screw press requires a high-performance chocking at the support legs to ensure stability and minimize vibrations

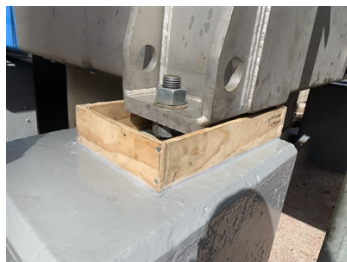
Formwork was built around the support legs before pouring the Belzona chocking system

1. Timber battens were coated in Belzona 9411 Release Agent
2. A dam was created in 16 locations using screws and silicon, left to cure overnight.
3. Belzona 7111 was mixed and poured in accordance with Belzona 7111 IFU, and was left to cure for 24 hours before removing timber battens.

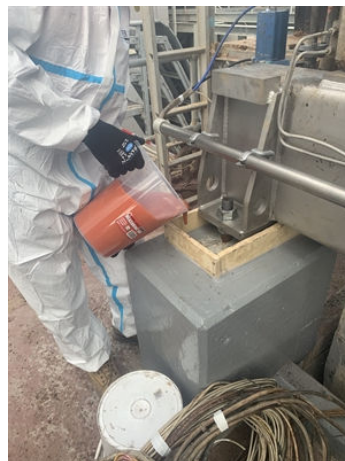
Pouring Belzona 7111

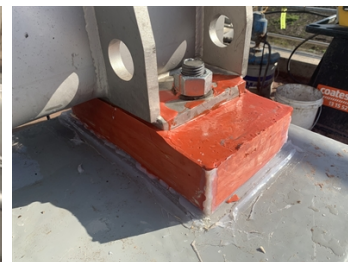
Completed application of Belzona 7111, 100% solids chocking/grouting material

Belzona 7111 was used as it is a self leveling system to create a perfectly even base for the screw press.
