# BELZONA SOLUTION FOR REBUILDING AND COATING OF GLOBE VALVE

ID: 9760

**Industry:** Oil & Gas  
**Application:** VPF-Valves, Pipes and Fittings  
**Substrate:** Bronze  
**Products:** Belzona 1111 (Super Metal), Belzona 1321 (Ceramic S-Metal)

**Customer Location:** ABU DHABI, UNITED ARAB EMIRATES  
**Application Date:** February 2024

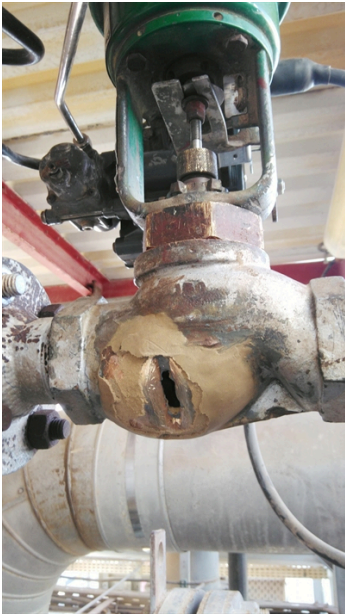
Globe valve that had developed a hole, leading to operational disruptions.
