BELZONA SOLUTION FOR TAIL SHAFT REPAIR AND COATING

ID: 9761

Industry: Marine
Application: SOS-Ships and Offshore Structures

Customer Location: ABU DHABI, UNITED ARAB EMIRATES
Application Date: March 2017

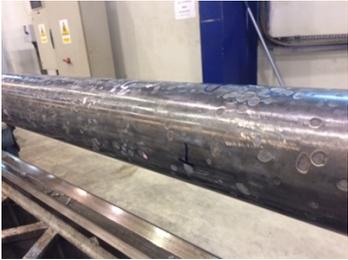
One of our valued marine customers faced severe pitting on the exposed section of a vessel's tail shaft due to prolonged seawater exposure and barnacle adhesion. Over time, the harsh marine environment and biofouling caused localized corrosion, leading to deep pitting on the shaft surface.

The accumulation of barnacles further accelerated the corrosion process, contributing to surface degradation and potentially affecting the tail shaft's structural integrity and operational efficiency. This issue highlights the challenges of marine asset maintenance and reinforces the need for effective protective measures to prevent corrosion-related damage in seawater-exposed components.

Severe pitting on the exposed section of a vessel's tail shaft due to prolonged seawater exposure and barnacle adhesion
