BELZONA SOLUTION FOR TAIL SHAFT REPAIR AND COATING

ID: 9761

Industry: Marine
Application: SOS-Ships and Offshore Structures

Customer Location: ABU DHABI, UNITED ARAB EMIRATES
Application Date: March 2017

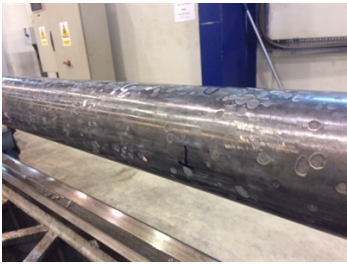
One of our valued marine customers faced severe pitting on the exposed section of a vessel's tail shaft due to prolonged seawater exposure and barnacle adhesion. Over time, the harsh marine environment and biofouling caused localized corrosion, leading to deep pitting on the shaft surface.

The accumulation of barnacles further accelerated the corrosion process, contributing to surface degradation and potentially affecting the tail shaft's structural integrity and operational efficiency. This issue highlights the challenges of marine asset maintenance and reinforces the need for effective protective measures to prevent corrosion-related damage in seawater-exposed components.

Severe pitting on the exposed section of a vessel's tail shaft due to prolonged seawater exposure and barnacle adhesion

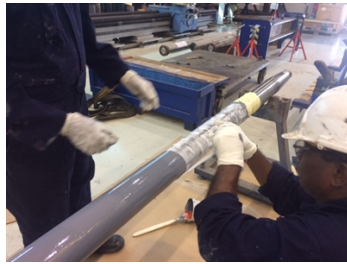
The first coat of Belzona 1321 (Ceramic S-Metal) was applied.

The Belzona Tail Shaft Wrap System was applied in accordance with Belzona Know-How System Leaflet SOS-6, utilizing two layers of Belzona 1321 (Ceramic S-Metal) reinforced with Belzona 9341 Reinforcement Tape. This system provides exceptional corrosion and abrasion protection for the tail shaft, with the 9341 tape enhancing the strength of the coating. The process involved machining a 2 mm rebate on the shaft, creating a rough thread profile for surface preparation, and degreasing the surface. Areas not to be coated were masked off before applying the first coat of Belzona 1321. The surface was then wrapped with Belzona 9341, ensuring a 6 mm overlap, followed by a second coat of Belzona 1321 to fully encapsulate the reinforcement.

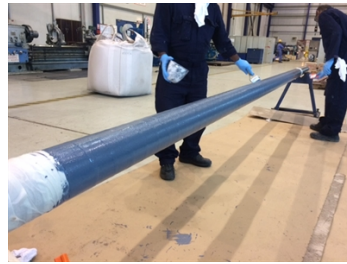
Wrapped with Belzona 9341 Reinforcement Tape, ensuring a 6 mm overlap, before the second coat of Belzona 1321 (Ceramic S-Metal).

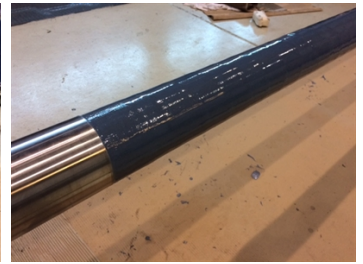
Finally, two coats of Belzona 1321 (Ceramic S-Metal) were applied, following the Belzona Instructions for Use (IFU), to provide superior protection and long-term performance.
