# BELZONA SOLUTION FOR TAIL SHAFT REPAIR AND COATING

ID: 9761

Industry: Marine  
Application: SOS-Ships and Offshore Structures

Customer Location: ABU DHABI, UNITED ARAB EMIRATES  
Application Date: March 2017

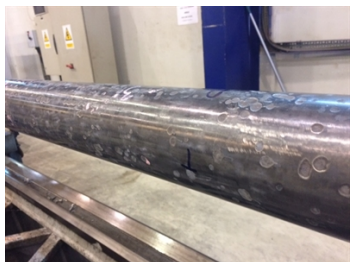
One of our valued marine customers faced severe pitting on the exposed section of a vessel's tail shaft due to prolonged seawater exposure and barnacle adhesion. Over time, the harsh marine environment and biofouling caused localized corrosion, leading to deep pitting on the shaft surface.

The accumulation of barnacles further accelerated the corrosion process, contributing to surface degradation and potentially affecting the tail shaft's structural integrity and operational efficiency. This issue highlights the challenges of marine asset maintenance and reinforces the need for effective protective measures to prevent corrosion-related damage in seawater-exposed components.

Severe pitting on the exposed section of a vessel's tail shaft due to prolonged seawater exposure and barnacle adhesion

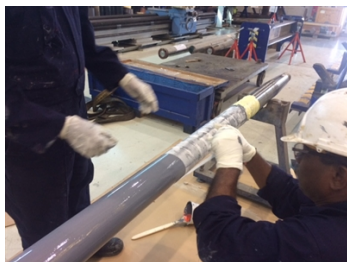
The first coat of Belzona 1321 (Ceramic S-Metal) was applied.

The Belzona Tail Shaft Wrap System was applied in accordance with Belzona Know-How System Leaflet SOS-6, utilizing two layers of Belzona 1321 (Ceramic S-Metal) reinforced with Belzona 9341 Reinforcement Tape. This system provides exceptional corrosion and abrasion protection for the tail shaft, with the 9341 tape enhancing the strength of the coating. The process involved machining a 2 mm rebate on the shaft, creating a rough thread profile for surface preparation, and degreasing the surface. Areas not to be coated were masked off before applying the first coat of Belzona 1321. The surface was then wrapped with Belzona 9341, ensuring a 6 mm overlap, followed by a second coat of Belzona 1321 to fully encapsulate the reinforcement.

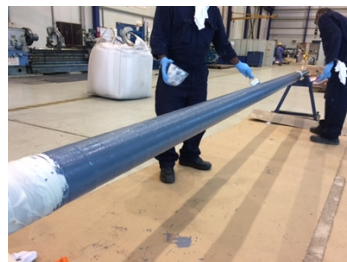
Wrapped with Belzona 9341 Reinforcement Tape, ensuring a 6 mm overlap, before the second coat of Belzona 1321 (Ceramic S-Metal).

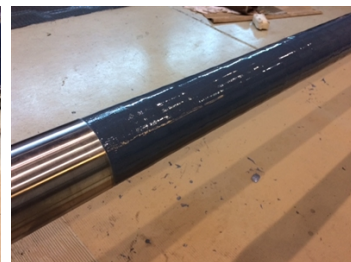
Finally, two coats of Belzona 1321 (Ceramic S-Metal) were applied, following the Belzona Instructions for Use (IFU), to provide superior protection and long-term performance.
