Belzona helps to protect HVAC End Covers Suffering Erosion & Corrosion

ID: 9765

Industry: Chemical & Petrochemical
Application: HEX-Heat Exchangers
Substrate: Cast Iron
Products: Belzona 1391T

Customer Location: NSW Australia
Application Date: May 2023

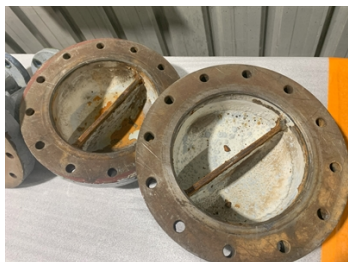
The asset owner was search for solutions for HVAC end covers that suffered from erosion and corrosion.

Existing condition of HVAC end covers suffered erosion & corrosion

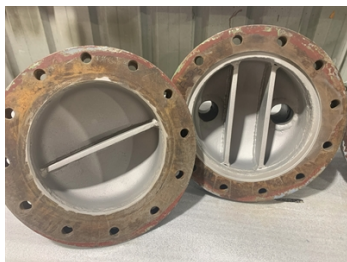
End covers were blasted for further repair steps

The end covers were abrasive blasted and coated with Belzona 1391T by the Belzona distributor for Australia, Rezitech Services team in Sydney.

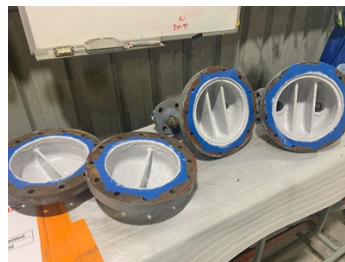
First coat of Belzona 1391T Grey

Belzona 1391T was recommend due to the elevated temperature of 85°C.

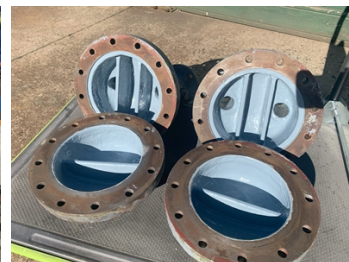
End covers completed with second coat Belzona 1391T Blue

Inspections have been extended to 8 year intervals saving downtime on critical process equipment
