# Belzona Superwrap II Restores Fuel Storage Tank Pipeline

ID: 9767

Application: VPF-Valves, Pipes and Fittings

Customer Location: NSW Australia

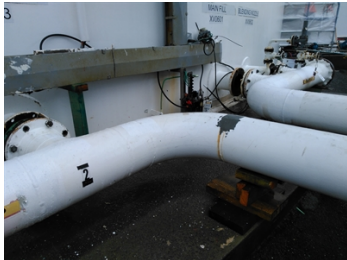
Pipeline to storage tank was suffering from thin wall corrosion at the weld seam.

Pipeline to storage tank.

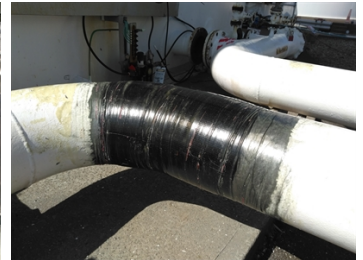
Super Wrap II repair completed

Belzona Superwrap II 10-year compliant repair installed by the onsite Rezitech Services Team
