Bearing housing repair with Belzona 1111

ID: 9769

Application: MPT-Mechanical Power Transmission

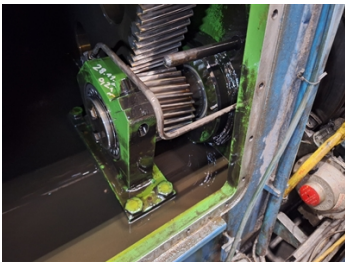
Gearbox with damaged bearing

After prolonged operation, the bearing housing began to vibrate and lost its prescribed geometry. If it were to continue operating, there was a risk of damage to the entire gearbox.

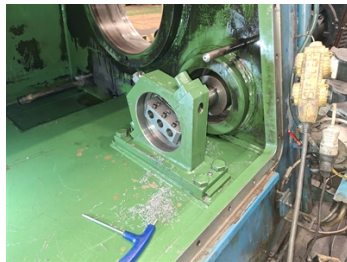
Treatment of damaged surface prior to application of Belzona 1111

The gearbox bearing housing was bored using a mobile boring machine with a VHU boring head. The hole was undercut both in front of and behind the central lubrication groove, which served as a reference plane for centering. The undercut was done using a forged thread cutter. The housing was degreased. Belzona 1111 was then applied. After curing, the Belzona was machined to the final dimension with +0.01.

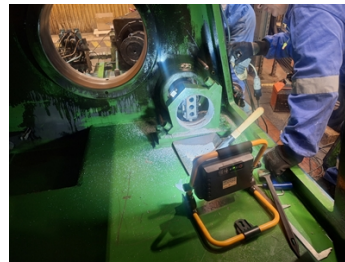
Surface machining after application of Belzona 1111
