METAL PLATE BONDING ON DAM STRUCTURE

ID: 9774

Industry: Water / Wastewater

Application: VPF-Valves, Pipes and Fittings

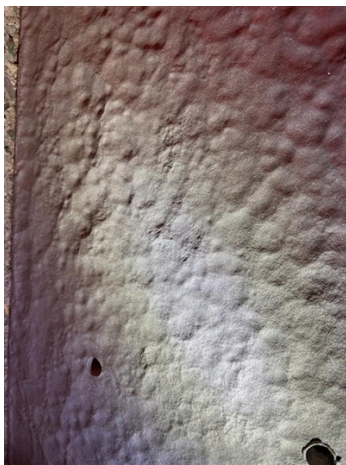
Dam structure was badly worn by erosion of river running beneath and it required reinforcement. Due to the areas affected, welding was not an option. Engineering consulting company specified Belzona to bond metal plated to the structure for reinforcement and corrosion protection.

Structure before metal bonding.

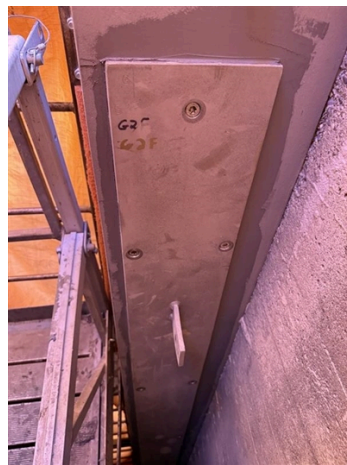
Structure after metal bonding with Belzona 1121.

Existing structure and plate was blasted to SSPC SP10 standard of cleanliness. Belzona 1121 was applied on both the structure and the plate for a wet on wet application. Due to freezing conditions, heater were put on to enable proper curing at favourable conditions. Belzona 5811 was then applied to seal the perimeter around the bonding area. Necessary inspections were carried out after few weeks and application was certified okay.

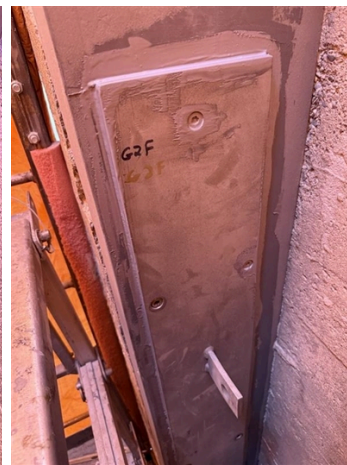
Perimeter of the bonded area coated with Belzona 5811.
