BELZONA HELPS WITH STERN TUBE REALIGNING

ID: 9775

Application: SOS-Ships and Offshore Structures

Application Date: February 2025

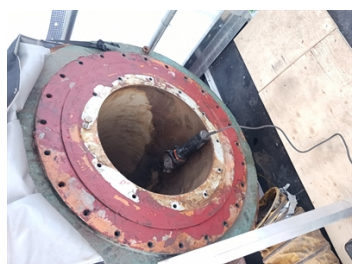
Stern tube after cleaning.

Affected stern tube lining was blasted to the level of cleanliness as instructed in the product IFU. Surface was degreased and Belzona 1111 was applied and machined to the required dimension. Two coats of Belzona 1321 were applied afterwards to seal the area. The application was inspected and passed for the alignment of the propeller.

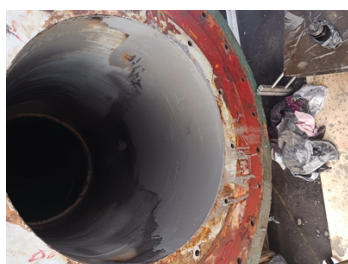
Belzona 1111 application completed.

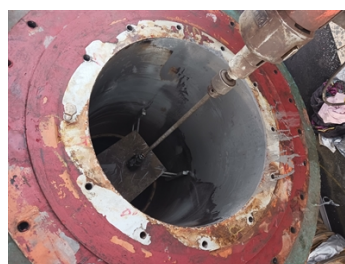
Machining down to required dimensions.

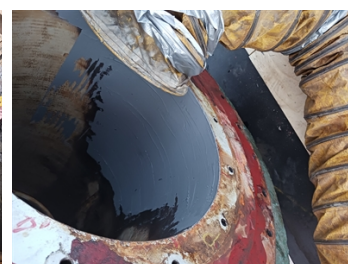
Belzona 1321 application completed.
