Bunker Fuel Transfer Pump Repair

ID: 9776

Industry: Marine
Application: CEP-Centrifugal Pumps
Substrate: Carbon steel
Products: Belzona 1161 (Super UW-Metal)

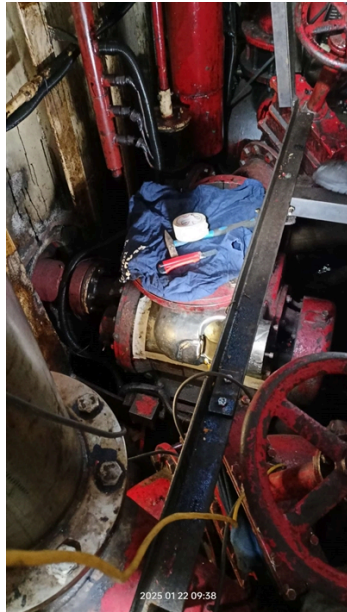
Prepared surface.

The surface was roughened through grinding and subsequently cleaned. A first layer of Belzona 1161 was applied to the internal and external sides of the bypass valve. Belzona Reinforcement tape, embedded on both sides with Belzona 1161, was used to strengthen the repair, which was then covered with an additional layer of Belzona 1161.

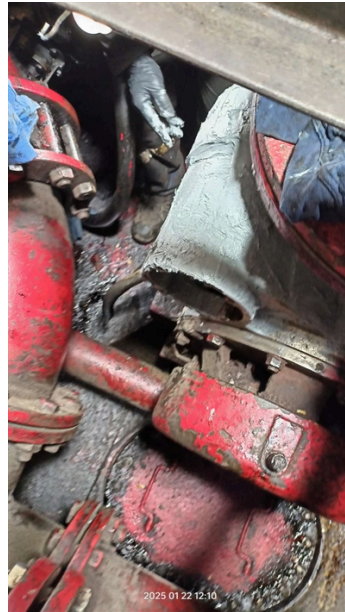
Belzona Super Metal application.
