# Ship Deck Got The Belzona Plate Bonding Treatment

**Industry:** Marine  
**Application:** FPA-Floor Problem Areas  
**Substrate:** Carbon steel  
**Products:** Belzona 1111 (Super Metal), Belzona 5811 (Immersion Grade)

**Customer Location:** Hamilton, Ontario

**Application Date:** March 2025

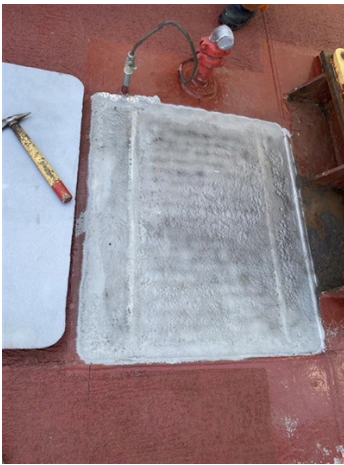
Deck area after abrasive blasting.

Area to be repaired and plate to be bonded were both grit blasted to SSPC SP10 level of cleanliness. Solvent wiping was done afterward to get rid of remaining contaminants after vacuuming. Belzona 1111 was applied separately on both area and the plate and then bonded together to give a wet on wet application. After stabilization, Belzona 5811 was applied on the area to seal the perimeter and also give extra protection.

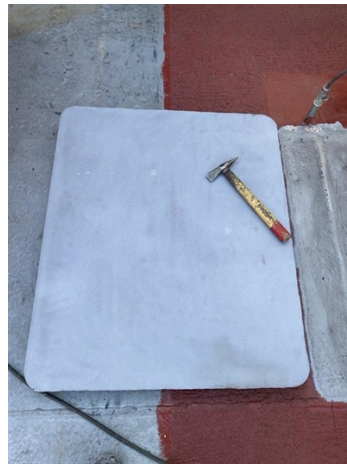
Plate after abrasive blasting.

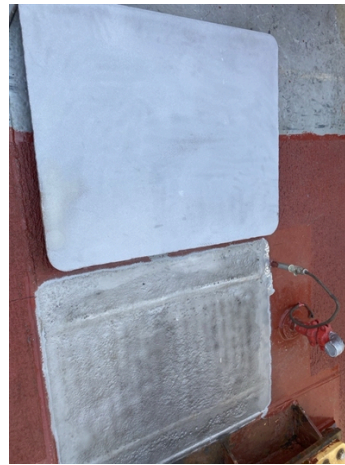
Both side by side.

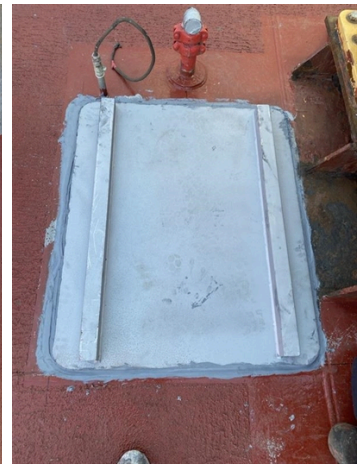
Deck floor was experiencing deterioration around mess room top. With critical connections around the area, welding would be too much of a risk. Consultant contacted us and we suggested plate bonding to reinforce the area and protect from further damage.

Area after bonding.
