Baler interior was rescued from wear.

ID: 9783

Industry: Food & Drink
 Application: TCC-Tanks and Chemical Containment Areas
 Substrate: Carbon steel
 Products: Belzona 1121 (Super XL-Metal)

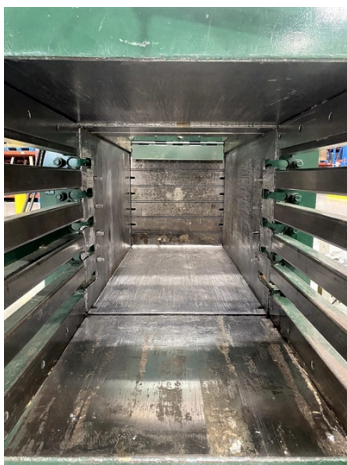
Baler lining after power tool cleaning before application of Belzona 1121.

Power tool were used to clean the surface and created required profile. Belzona 1121 was mixed and applied, then smoothed to give a more uniform application for ease of ramming of the loader. Equipment was put to test and customer was satisfied with the result.

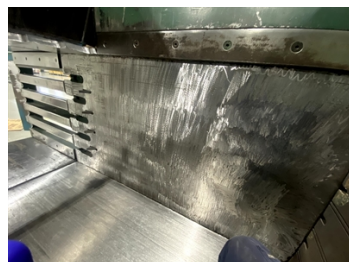
Side view of cleaning.

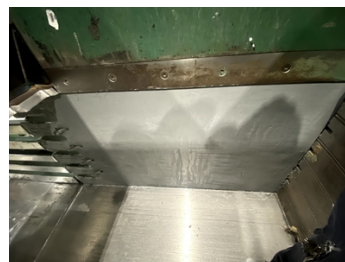
Side view of application.

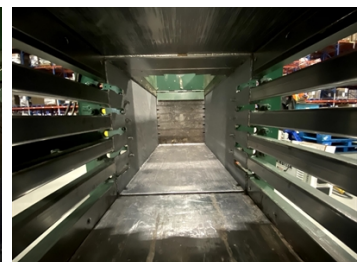
Both sides after application.
