# Belzona Solutions for Rubber Balloon Crack Repair

ID: 9784

Application: SOS-Ships and Offshore Structures

Products: Belzona 2111 (D & A Hi-Build Elastomer), Belzona 2211 (MP Hi-Build Elastomer), Belzona 2921 (Elastomer GP Conditioner), Belzona 9111 (Cleaner Degreaser)

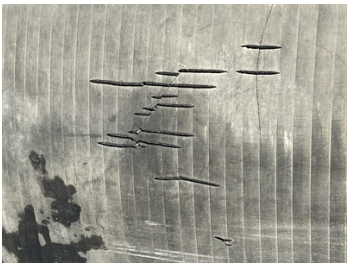
Significant cracking in their floating rubber balloons, mainly caused by dredging operations in the sea.
