# Power Plant Hydrocyclone repaired with Belzona

Industry: *Power*  
Application: *TCC-Tanks and Chemical Containment Areas*  
Substrate: *Carbon steel*  
Products: *Belzona 1811 (Ceramic Carbide)*

Customer Location: *Trimble County*  
Application Date: *July 2010*

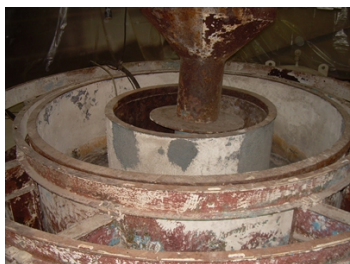
*Severe wear due to abrasion caused this hydrocyclone to lose its efficiency.*

A well used Hydrocyclone

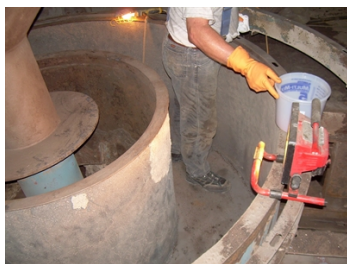
Applying Belzona 1811 (Ceramic Carbide)

Unit was grit blasted to SSPC SP 10 then washed down with MEK. Belzona 1811 (Ceramic Carbide) was mixed and applied according to the products Instructions for Use.

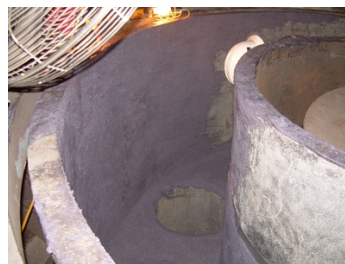
Belzona 1811 (Ceramic Carbide)

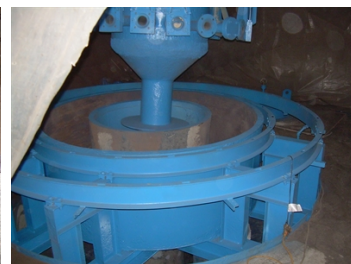
Finished application and fresh paint
