BELZONA MEMBRANE TO THE RESCUE

Industry: Buildings & Structures
Application: RPA-Roof Problem Areas
Substrate: Felt
Products: * Belzona 3131 (WG Membrane) ,

Customer Location: Hotel, Edinburgh, Scotland
Application Date: December 2007

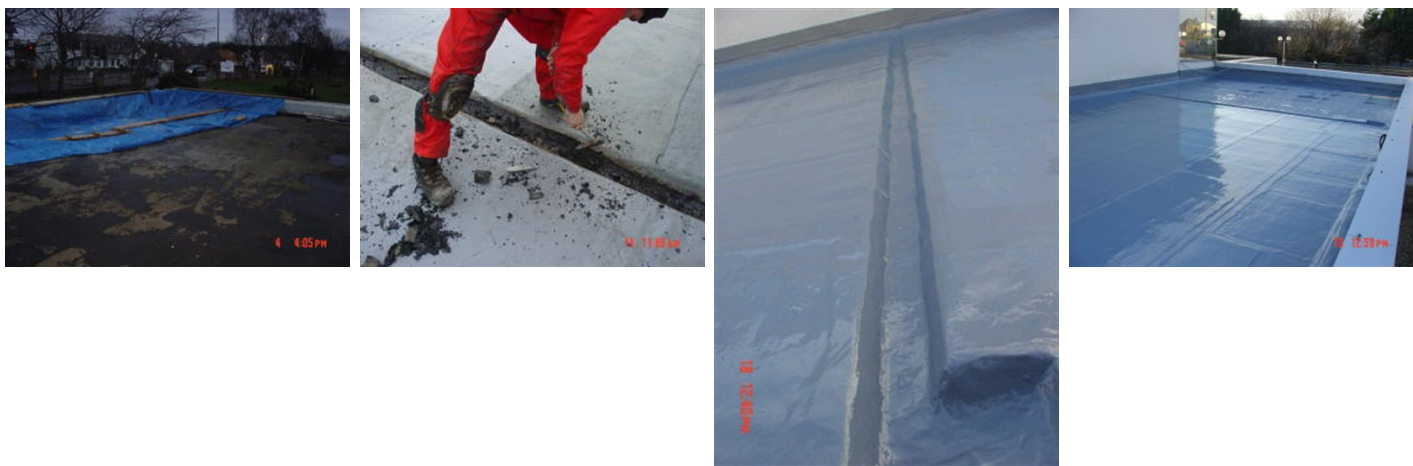
Photograph Descriptions

Water penetrating gutter joints due to weight of water on the joints. Owner required immediate repairs to prevent disruption to business.

- * View of the "tired" and uncoated roof ,
- * Area where water was penetrating ,
- * Completed gutter, the main problem area ,
- * Completed Belzona application ,

The application was carried out in accordance with Belzona Know-How System Leaflet RPA-1 and RPA-6.
