Tank Protection at an Oil Terminal with Belzona

ID: 9792

Application: TCC-Tanks and Chemical Containment Areas

Application Date: March 2025

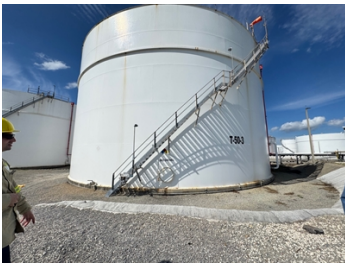
Tank T-50-3 at a biodiesel terminal. Water ingress was identified around the tank base, causing localized corrosion and posing a risk to structural integrity.

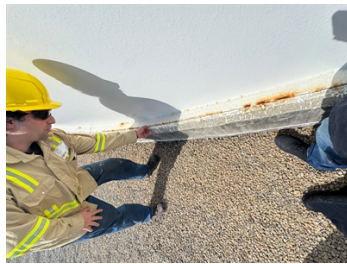
During the initial inspection, rust was observed at the junction between the tank ring and the concrete base — a clear indicator of moisture infiltration.

The customer was experiencing water ingress underneath the base of an 87-foot tank. This constant exposure to moisture posed a risk of corrosion and potential long-term structural deterioration. A solution was needed to seal the area and protect the asset from further damage due to environmental conditions.

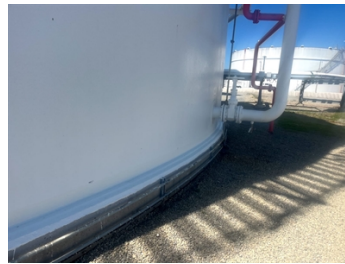
Belzona sealing system being applied. The first layer of Belzona 3111 is reinforced to ensure both mechanical strength and flexibility.

The application began with sandblasting to remove corrosion and contaminants, creating the ideal surface profile. Belzona 3921 was applied as a conditioner, followed by a first layer of Belzona 3111, reinforced with Belzona 9311 sheet. A second layer of 3111 sealed the system.

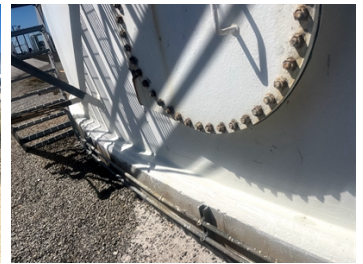
Completed coating with Belzona 3111, forming a seamless and durable barrier against water ingress. An effective and aesthetic protection to extend the asset's service life.
