# Belzona Gives Better Protection on External Lining of Water Well Pump

Industry: Oil & Gas  
Application: CEP-Centrifugal Pumps  
Substrate: Carbon steel  
Products: Belzona 5821

Customer Location: RAS LAFFAN INDUSTRIAL CITY, QATAR  
Application Date: September 2022

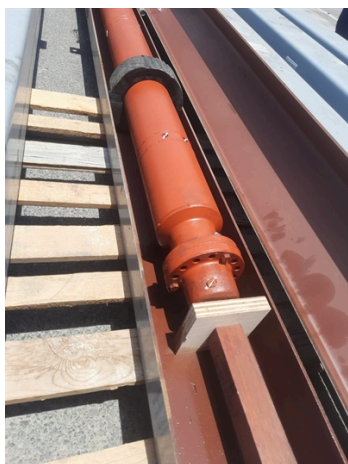
The newly fabricated well pump coated with red epoxy primer.

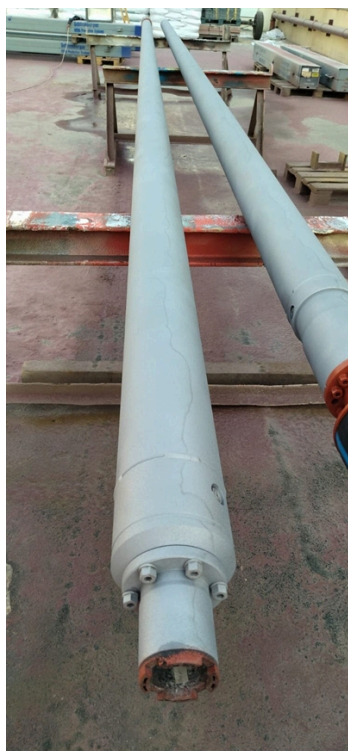
Using vapour blasting, the epoxy primer is being removed and metal surface was exposed.

1. The water well pump was initially blasted in accordance with Belzona guidelines of Surface Preparation procedure written in the IFU (Instructions for Use) which is to provide a required Cleanliness Standard of SA 2.5 with a minimum of 75 microns surface profile.
2. Belzona 5821 coating application was done in accordance with System Leaflet CEP-4 provided with an approved method statement. The coating was applied by manual application by stiff bristled brush in a thin layer per coat with maximum thickness of 150 microns only to maintain the smoothness of the coating being applied preventing it from sags occurrence.
3. Three-coat system was done to achieve the required thickness of minimum 400 microns but not more than 500 microns.

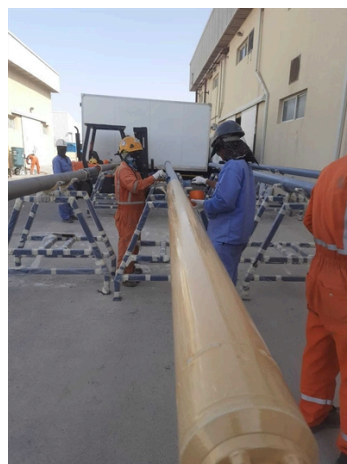
Belzona 5821 coating application was done in 3 coat system to achieve the required thickness of 400-500 microns.

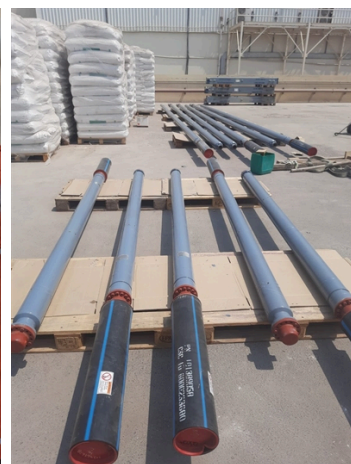
Belzona 5821 application was completed with a final coat in slate grey.
