# IN-SITU BELZONA REPAIR TO DRYER ROLLER

Industry: *Pulp & Paper*  
Application: *MPT-Mechanical Power Transmission*

Customer Location: *Paper Mill in France*  
Application Date: *May 1993*

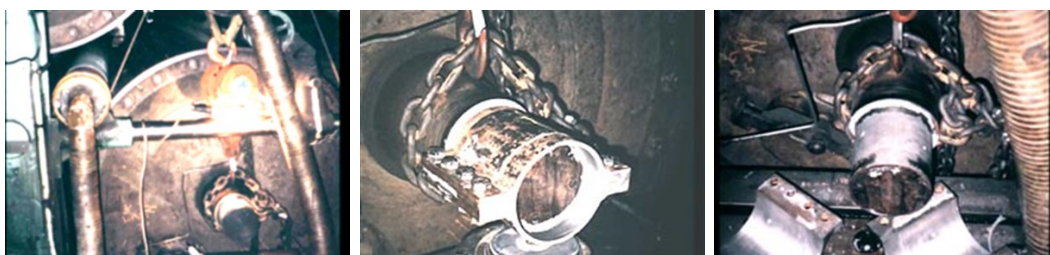
*Collapse of bearing caused damage to the journal*

- \* General view of the damaged drying roller journal ,
- \* Former clamped in place ,
- \* Former removed showing accurately rebuilt journal ,

Bearing journal on dryer roller of paper machine

Application was carried out in accordance with Belzona System Leaflet MPT-2.

This application was completed in half a day whereas traditional repair would have involved dismantling of the machine and would have taken more than two days and associated loss of production. After 5 years, repair is still in service and the customer was totally satisfied.
