# Belzona SuperWrap II Repair & Reinforcement of Seawater Pipelines on LNG Ship

Industry: Marine  
Application: SOS-Ships and Offshore Structures

Customer Location: Turkey / Yalova  
Application Date: February 2025

Substrate: NAB Nickel Aluminum Bronze  
Products: Belzona 1212, Belzona 1981 (SuperWrap II)

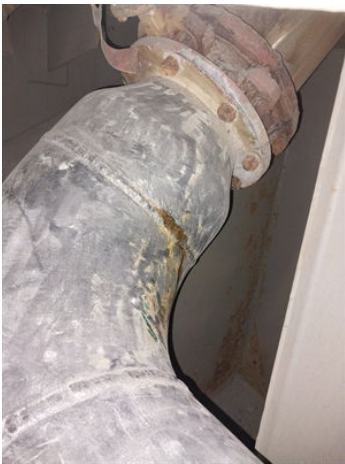
Weakened and leaking areas in the pipelines.
