# Repair of Small Gouges in Bearing Housing Using Belzona 1511

Industry: Mining & Quarrying

Application: MPT-Mechanical Power Transmission

Substrate: Carbon steel

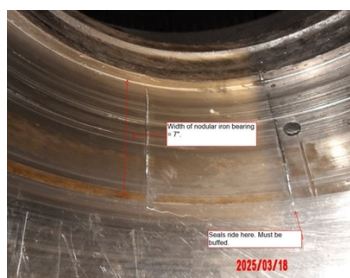
View and dimensions of some of the damaged sections

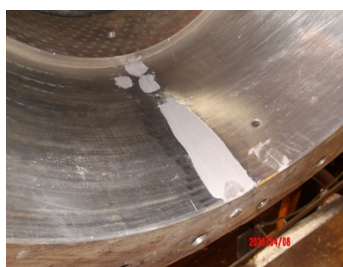
Larger gouges repaired and sanded

The bearing housing was first prepared by mechanically roughening the surface to remove any contamination and create a strong mechanical profile. The surface was then cleaned to eliminate dust, grease, and debris. Belzona 1511 was thoroughly mixed and applied to the gouged areas, ensuring complete filling of the voids. The material was built up beyond the final required dimensions to allow for machining. After full cure, the rebuilt areas were precision-machined to restore the original profile of the bearing housing.

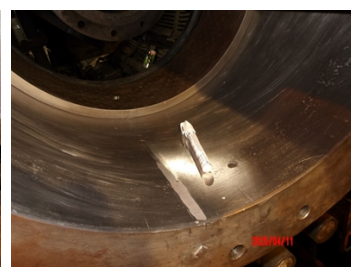
Thinner gouges filled and sanded
