# Evaporator Heat Transfer Tube

ID: 9807

**Industry:** General Industry  
**Application:** VPF-Valves, Pipes and Fittings  
**Substrate:** Carbon steel  
**Products:** Belzona 1161 (Super UW-Metal), Belzona 1984, Belzona SuperWrap II

**Customer Location:** Derbyshire, UK  
**Application Date:** May 2025

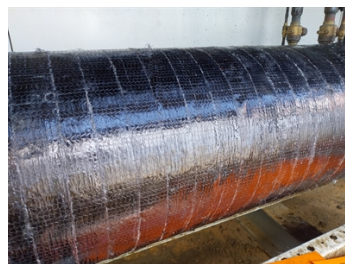
Wrapping the tube after wetting out the tube and composite wrap

Once these were cured, the tube was wetted out with Belzona 1984, as was the composite sheets

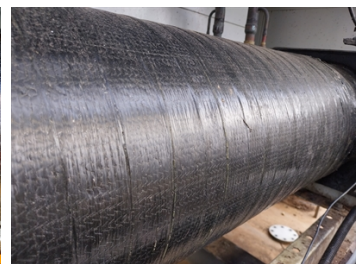
Wrap completed

2 wraps were considered enough for this application and all works were carried out in under 3 hours
