BELZONA RESTORES SCHOOL TOWER

Customer Location: Primary School, UK
Application Date: November 2007

Two stone towers connected with a wrought iron construction at the top of an old school building.

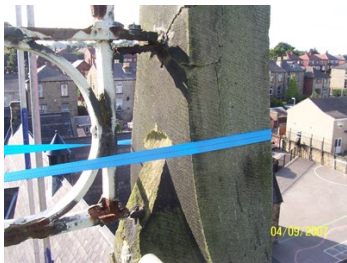
Cracking and spalling of 2 stone towers and corrosion of connecting wrought iron metalwork created a Health & Safety risk.

Application was carried out in accordance with Belzona Know-How System Leaflets WPA-4 & 8. The stonework was rebuilt with Belzona® 4231. Belzona® 1111 used to rebuild corroded wrought iron before protecting with Belzona® 6111/5111 system. Belzona®

5122 applied to stonework for long term protection.
