# BELZONA SOLUTION FOR REBUILDING AND COATING OF CHILLERS - 1M DIAMETER

ID: 9810

Industry: Heating, Ventilation & Air Conditioning  
Application: HEX-Heat Exchangers  
Substrate: Carbon steel  
Products: Belzona 1121 (Super XL-Metal), Belzona 5821

Customer Location: Dubai, United Arab Emirates  
Application Date: February 2025

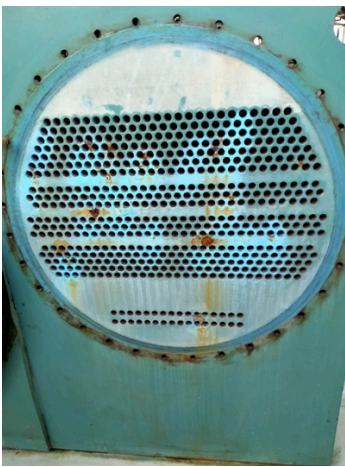
The tube sheet and end cover of the chiller units suffered from severe corrosion, leading to a notable reduction in operational efficiency.

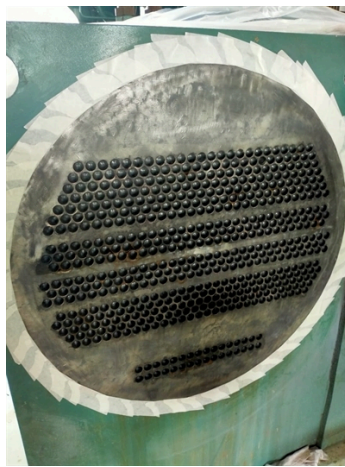
Surface preparation and profile testing were carried out using blasting for the end covers and hand tools for the tube sheet face.

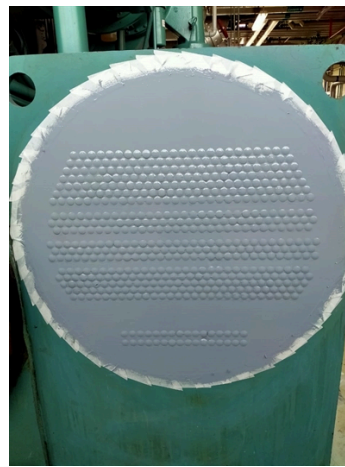
Belzona 1121 (Super XL-Metal) was used to rebuild and resurface the worn areas.

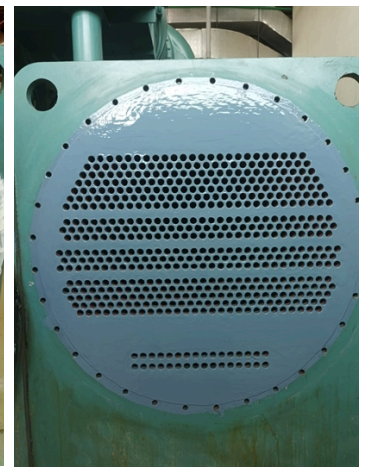
Belzona 5821 was applied as a two-coat system to protect the tube sheet and end cover from corrosion and erosion.
