Externally corroded pipe restored and strengthened

ID: 9813

Application: VPF-Valves, Pipes and Fittings

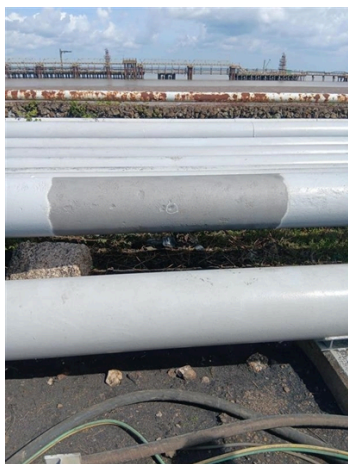
Customer identified an area of corrosion on their JP-51 pipeline, resulting in reduced wall thickness. The affected section was believed to have thinned to 5.31mm

External corrosion had caused deep pitting in the pipe

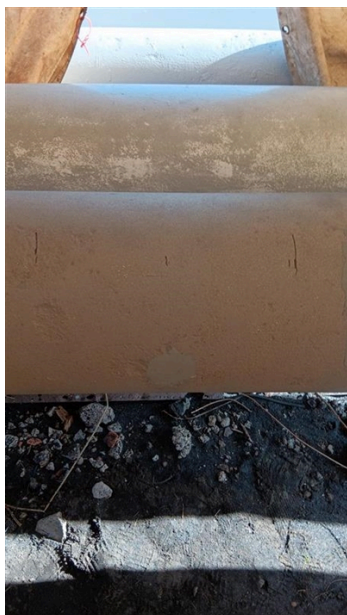
Belzona 1111 is applied to prepared surface to bring back to profile

The area was grit blasted to minimum surface profile, cleaned down and made dust free. The defect area was reprofiled using Belzona 1111 and allowed to become stable for an estimated 1 hour. Finally, our Belzona® SWII system was applied over the complete circumference area in 6 layers, before being wrapped with Belzona® 9381, consolidation tape. The following morning the consolidation tape was removed and a full inspection carried out by a Belzona supervisor.

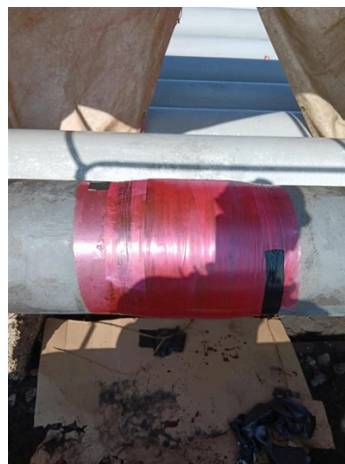
Belzona 1981 SuperWrap II system has six layers applied and consolidated with tape

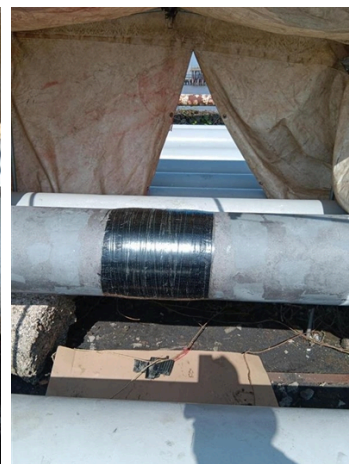
Finished application, restoring integrity and increasing strength to pipe
