Four Stage Submersible River Water Pump

ID: 9815

Application: CEP-Centrifugal Pumps

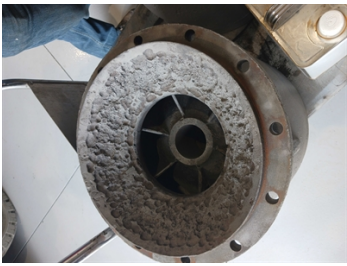
After many years of pumping river water the pump bowls had severe corrosion issues and required rebuilding

Bowl 1 Corrosion blasted and ready for rebuilding with Belzona 1111

Pumps were dismantled by the CMF Millwrights and blasted and than cleaned using Belzona 9111, Belzona 1111 was mixed using the Belzona tooling and application started by using a short bristle brush to fill heavy corrosion areas and finished using a Belzona applicator.

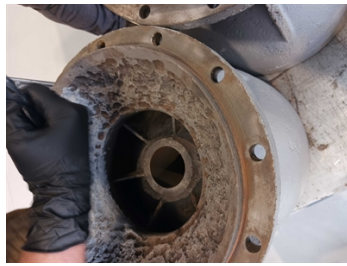
Rebuilding started using Belzona 1111 application by short bristle brush
