# Four Stage Submersible River Water Pump

ID: 9815

Application: *CEP-Centrifugal Pumps*

Substrate: *Cast Iron*

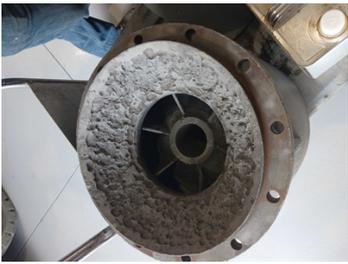
*After many years of pumping river water the pump bowls had severe corrosion issues and required rebuilding*

Bowl 1 Corrosion blasted and ready for rebuilding with Belzona 1111

Pumps were dismantled by the CMF Millwrights and blasted and than cleaned using Belzona 9111, Belzona 1111 was mixed using the Belzona tooling and application started by using a short bristle brush to fill heavy corrosion areas and finished using a Belzona applicator.

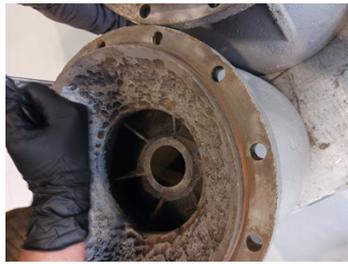
Rebuilding started using Belzona 1111 application by short bristle brush

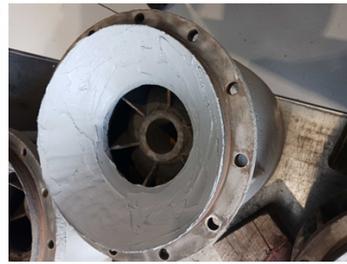
First bowl application completed

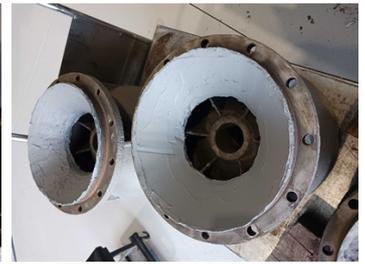
Two bowls completed and ready for machining
