# Plate bonding repair on glass infused tanks ensures integrity of tank

**Industry:** Water / Wastewater  
**Application:** TCC-Tanks and Chemical Containment Areas  
**Substrate:** Stainless-steel  
**Products:** Belzona 1111 (Super Metal), Belzona SuperWrap II

**Customer Location:** Lemonroyd  
**Application Date:** April 2025

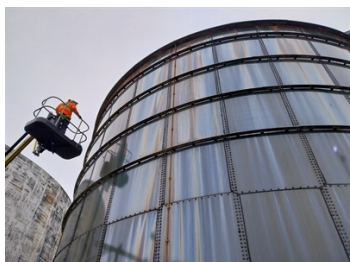
Inspection of sludge tanks to assess repair needs

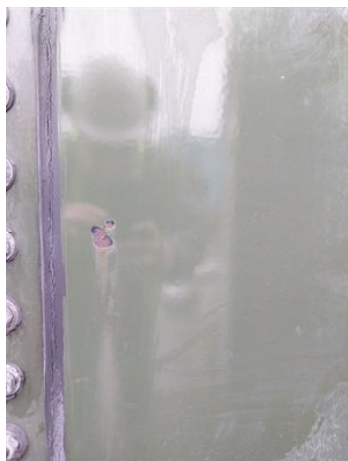
Sludge tanks for treatment works required several repairs for external corrosion on glass steel infused tank

Several areas of external corrosion/damage were identified

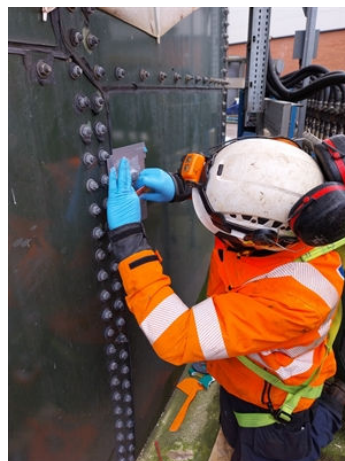
Carbon fibre plates were bonded using Belzona 1111

The surface of the tank was prepared with hand tools to minimum surface preparation. Using carbon fibre plates, the plates were bonded using Belzona 1111 to seal and ensure no further ingress of corrosion would affect the tank

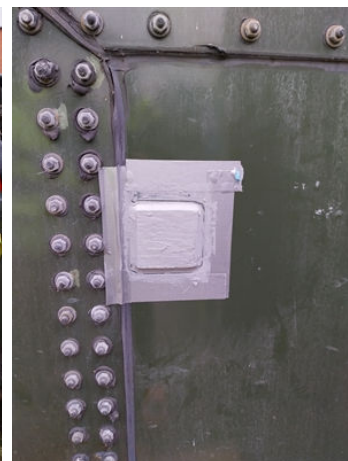
The solution ensures that no further corrosion can spread and weaken integrity of tank
