BELZONA PROTECTS CW PIPES AND BENDS

ID: 982

Customer Location: Power Station, UK
Application Date: May 2001

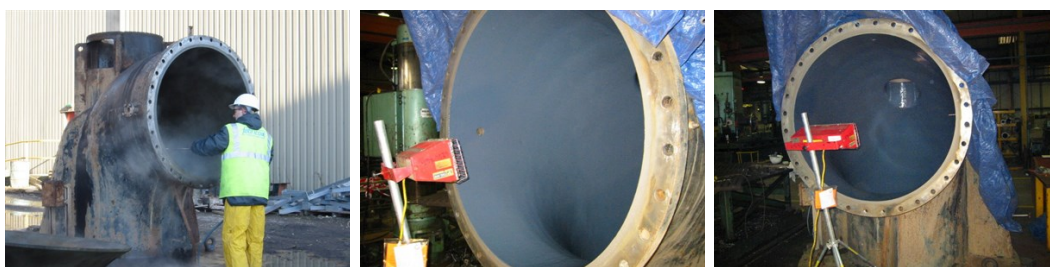
Photograph Descriptions

As a relatively new power plant on the banks of tidal estuary, the CW pumps and ancillary pipe work were showing significant erosion and corrosion after a short period of service. They were pumping large volumes of water from the river, which is very erosive even after it has been screened.

- * Bend being power washed to remove salts ,
- * & 3. Coated bend ,

Application was carried out in accordance with Belzona System Leaflets VPF-1 & VPF-2. Particular attention was paid to washing and blasting to remove salts, then badly eroded areas were re-built with Belzona® 1311 and then two coats of Belzona® 1321 applied.

The first bend, which is shown in the photographs, was opened up in March 2007 with a view to being refurbished. However when it was inspected, it was found to be in perfect condition.
