Flour Mixer Repair

ID: 9820

Industry: Food & Drink
Application: TCC-Tanks and Chemical Containment Areas
Substrate: Stainless-steel
Products: Belzona 1111 (Super Metal)

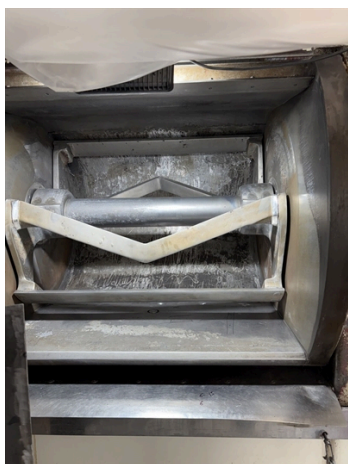
The surface on the patch and mixer were prepared using the high-performance rotary power tool, ensuring optimal adhesion and finish.

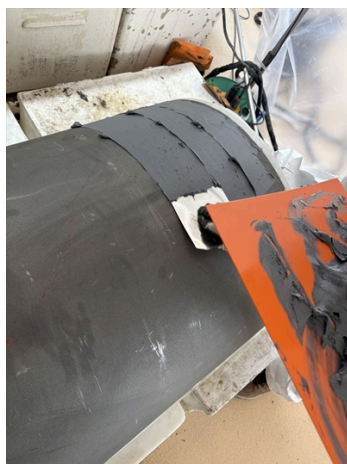
Super Metal was applied to both the patch surface and the mixer, delivering a durable, high-performance bond.

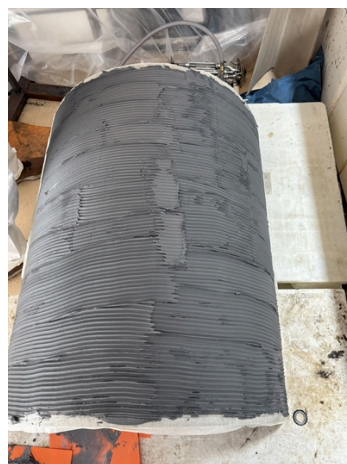
A uniform, homogenous application was achieved across both surfaces

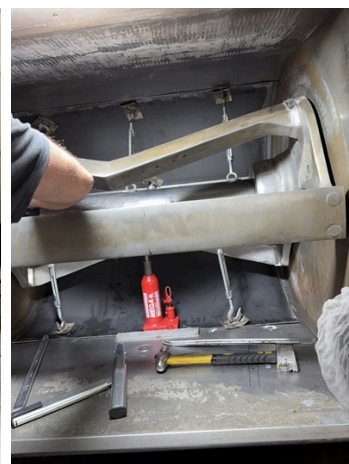
The patch was cold bonded and held securely in place until full curing was achieved, ensuring a strong and lasting repair.
