# Blade Repair and Protection with Belzona 5711 and Belzona 5721

Customer Location: Yai Thieng Mountain, North East Thailand

Application: FBC-Fans, Blowers and Compressors

Application Date: April 2023

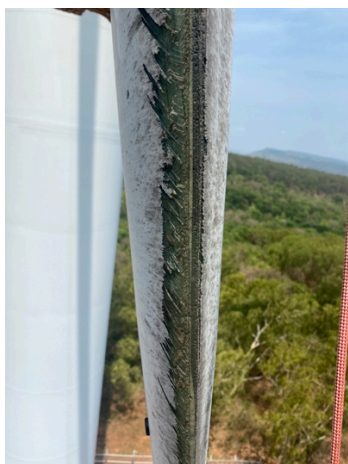
Pitting damage and coating deterioration because of rain erosion and UV attack at leading edge area.

Damage on the blade.

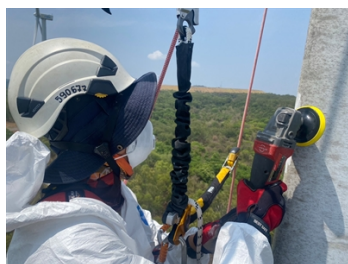
Surface preparation.

1. Sand the surface to be repaired using a coarse sander with 80-grit sandpaper, always using a new piece of sandpaper for each sanding operation.
2. Clean the surface with Belzona 9111 NF Cleaner, then allow it to dry completely.
3. Repair pitting with Belzona 5711.
4. Smooth Belzona 5711 using a coarse sander with 80-grit sandpaper.
5. Mix Belzona 5721 and apply it within 20 minutes using a high-quality brush. Apply at a wet film thickness of 500 microns and then allow it to fully cure for 5 hours at 30°C.

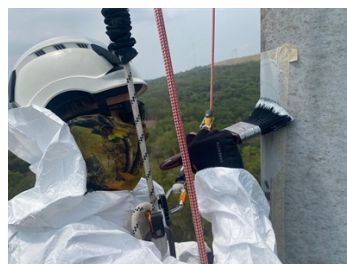
Application of Belzona 5721

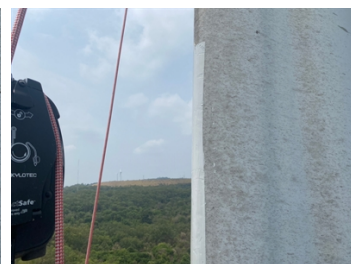
Completed application
