# Raised Flange Face Rebuild

ID: 9829

**Industry:** Oil & Gas  
**Application:** VPF-Valves, Pipes and Fittings  
**Substrate:** Carbon steel  
**Products:** Belzona 1111 (Super Metal), Belzona 9111 (Cleaner Degreaser), Belzona 9411 (Release Agent)

**Customer Location:** Ilderton Ontario  
**Application Date:** May 2025

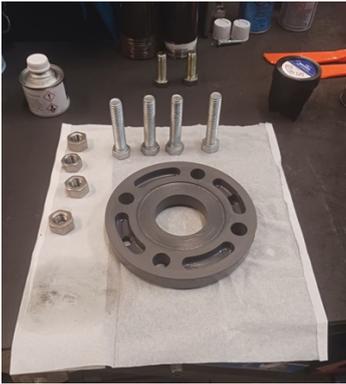
Former ready with Belzona 9411 applied

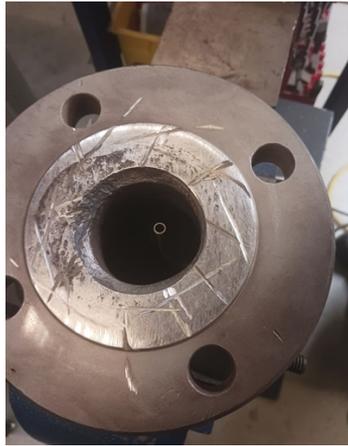
Surface Preparation completed of the flange

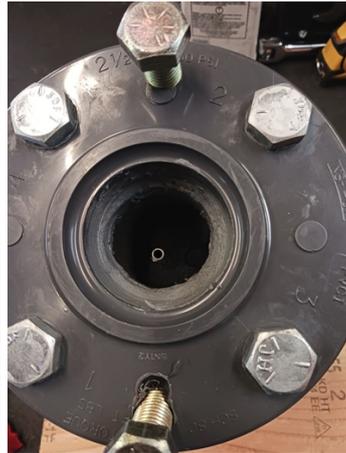
Belzona 1111 placed on flange and former, former bolted to valve body and torqued into place.

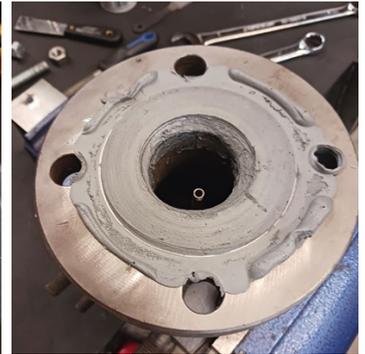
Belzona 1111 now cured and ready for final clean up.
