BELZONA LINING OF WATER TANK

ID: 983

Application: TCC-Tanks and Chemical Containment Areas

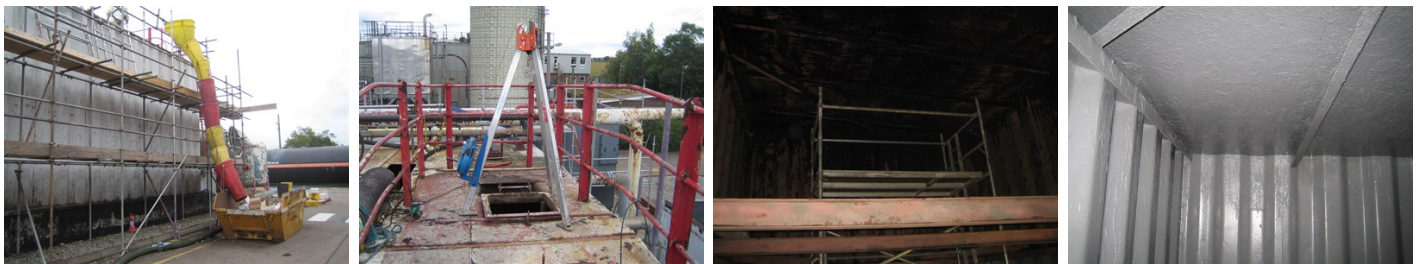
Photograph Descriptions

Over a period of years the interior lining of the tank had deteriorated to a point where it was both leaking and affecting the water quality.

* Tank showing method for disposing of waste and debris from within tank , * Top of Tank showing Hoist for vacuation of material and personnel , * Internal of Tank prior to Coating , * Internal of Tank after coating ,

Application was carried out in accordance with Belzona Know-How System Leaflet TCC-5.
