Superwrap II repairs on large diameter cooling water pipe

ID: 9831

Industry: Chemical & Petrochemical
Application: VPF-Valves, Pipes and Fittings
Substrate: Carbon steel
Products: Belzona 1161 (Super UW-Metal), Belzona 1981 (SuperWrap II)

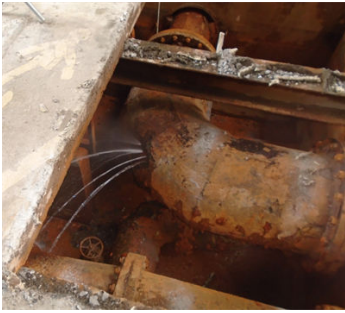
A cooling water pipe had several through wall defects. These had come from years of erosion & corrosion. The site depended on this pipe for production.

Leaking area on bend

The pipe was prepared using an MBX Bristle Blaster to the SSPC SP-11 surface preparation standard. More defects appeared during this process. All of the defects were plate bonded using pre fabricated Superpatch plates & Belzona 1161 UW Metal. Belzona 1981 was then applied & consolidated to reinforce these areas.

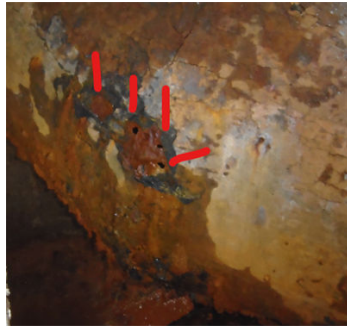
Close up of defects

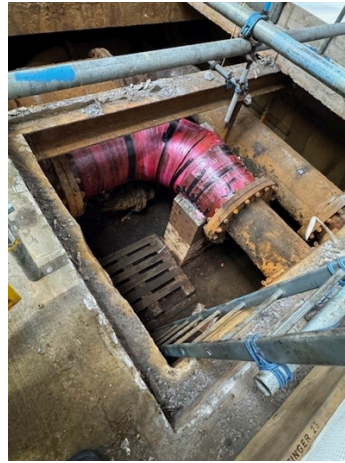
Wrap applied and consolidated

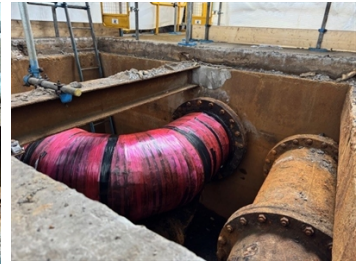
Completed repair

These repairs were completed in one day. Following this the system could return to service after the 24 hour cure period - this greatly helped the plant.
