Superwrap II repairs on large diameter cooling water pipe

ID: 9831

Industry: Chemical & Petrochemical

Customer Location: Scotland, UK

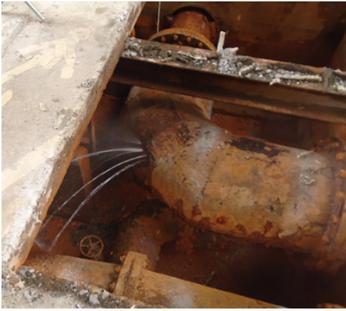
A cooling water pipe had several through wall defects. These had come from years of erosion & corrosion. The site depended on this pipe for production.

Leaking area on bend

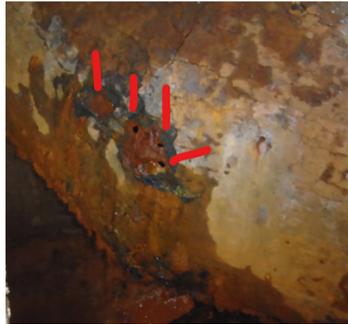
Close up of defects

The pipe was prepared using an MBX Bristle Blaster to the SSPC SP-11 surface preparation standard. More defects appeared during this process. All of the defects were plate bonded using pre fabricated Superpatch plates & Belzona 1161 UW Metal. Belzona 1981 was then applied & consolidated to reinforce these areas.

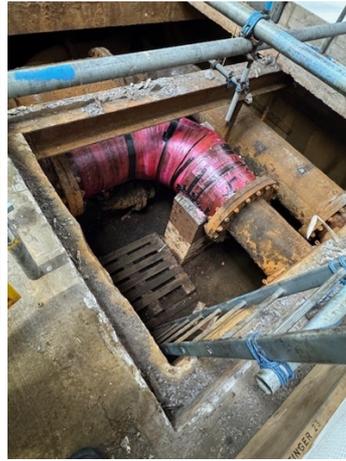
Wrap applied and consolidated

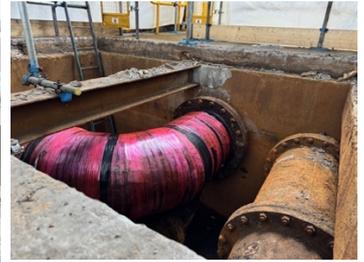
Completed repair

These repairs were completed in one day. Following this the system could return to service after the 24 hour cure period - this greatly helped the plant.
