# Complete Rehabilitation of Fire Pump

ID: 9832

Industry: Marine

Application: CEP-Centrifugal Pumps

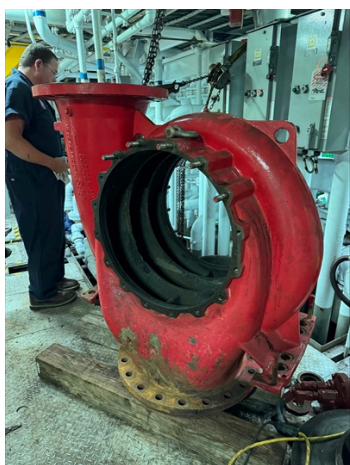
Initial condition of the fire pump casing before repair. Severe internal corrosion, wall loss, and surface damage are visible, requiring structural rebuilding and protective coating.

The internal surfaces of the fire pump casing were blasted to ensure proper mechanical adhesion. Surface cleanliness was verified,

and Belzona 9111 was used to remove contaminants. Belzona 1121 was applied using applicator tools to rebuild areas with wall loss and restore the original geometry. After curing, two coats of Belzona 1341 were applied by brush, the first in grey and the second in blue to ensure full coverage and visual confirmation of coating integrity.

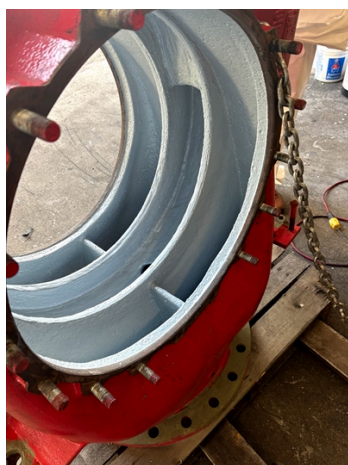
Restored fire pump casing after application of Belzona 1121 for rebuilding and two coats of Belzona 1341 for internal protection and hydraulic efficiency. The light grey topcoat indicates the completion of the first protective layer.

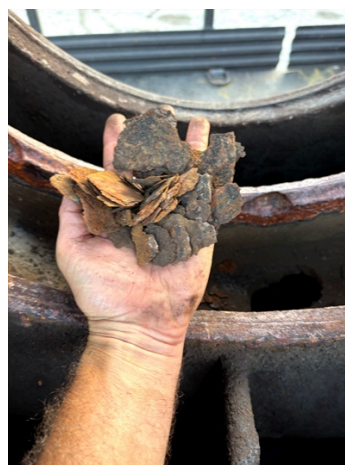
Large flakes of rust detached from the internal surfaces of the fire pump casing, highlighting the severity of corrosion and the urgent need for rehabilitation."

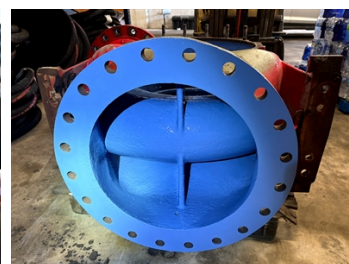
Fire pump casing fully rebuilt and coated. Final coat of Belzona 1341 Blue applied to improve hydraulic efficiency and provide long-term protection against corrosion and erosion.
