Water Tank Sprung Leak

ID: 9835

Application: TCC-Tanks and Chemical Containment Areas

Substrate: Carbon steel

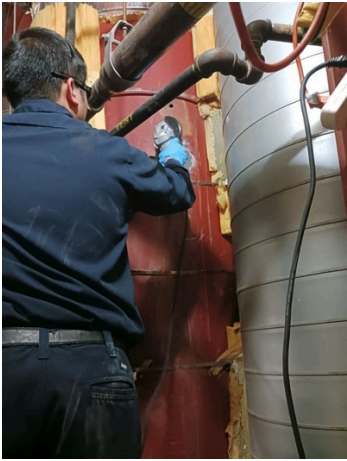
Preparation in progress at corrosion and holed area on water tank.

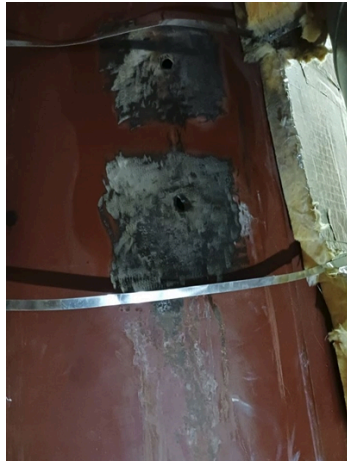
Repair areas on water tank ready for cold bonding of the new plates.

Method used was cold bonding new plates at repair areas, tooling used was a grinder with a 80 grit sanding disc and grinding wheel.

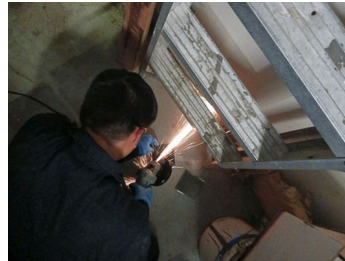
Preparation in progress of the new cold bonding plates.

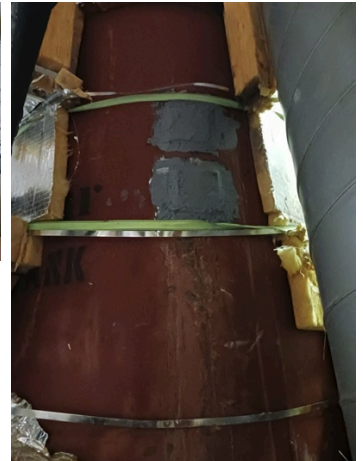
New cold bonded plates applied to tank using Belzona 1111
