# Tube Repair with Belzona SuperWrap

ID: 9836

Industry: Marine  
Application: SOS-Ships and Offshore Structures

Substrate: Carbon steel  
Products: Belzona 1982 (SuperWrap II)

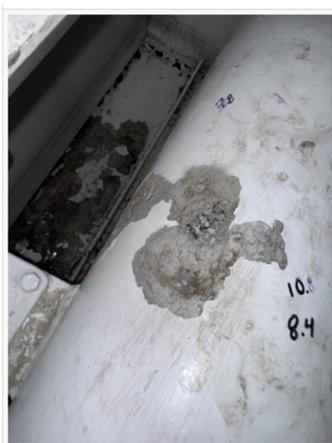
The inboard section of the stern tube presented severe corrosion, with extensive pitting and metal loss that compromised the component's integrity. Traditional repair options would have required hot work or full replacement, which was not ideal due to safety concerns and limited access. The client needed a cold-applied, high-performance solution that could be applied in confined spaces without dismantling the structure.

Visible pitting and metal loss on the inboard section of the stern tube before repair. Surface preparation and thickness readings marked prior to SuperWrap application.

The stern tube surface was first grit blasted with virgin crushed glass to achieve a minimum 2.5 mil profile. The damaged area was rebuilt using Belzona Super Metal to restore lost material and create a uniform profile. Thickness was verified using a PosiTector

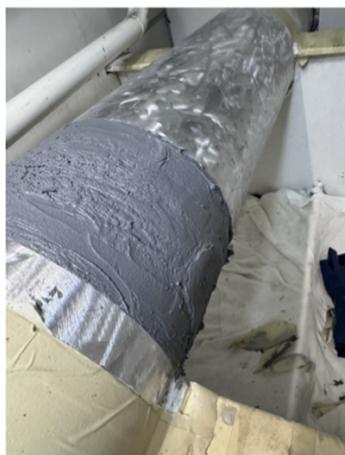
Post Belzona Super Metal application on stern tube. Surface was rebuilt prior to wrapping to ensure proper profile and integrity.

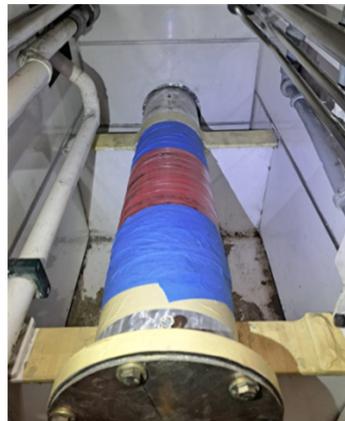
Final Belzona SuperWrap application on stern tube with release film in place. Wrap was applied following manufacturer guidelines to ensure proper compression and curing.

gauge. Belzona SuperWrap was then manually applied following the specified wrap pattern and layer count. Release film was used to compress the wrap during curing. After curing, the film was removed, revealing a smooth, reinforced surface. A protective topcoat was then applied over the SuperWrap II to enhance long-term durability. The application was completed in a confined marine compartment using hand tools and PPE for surface prep, mixing, and wrapping.

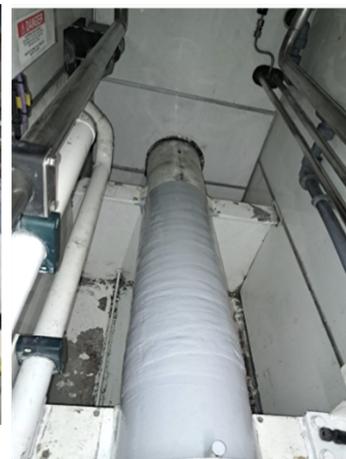
Completed Belzona SuperWrap application after release film removal. The final cured system restored structural integrity and provided a long-term corrosion protection solution.
