Briquetter Roll Shaft

ID: 9840

Industry: Chemical & Petrochemical
Application: MPT-Mechanical Power Transmission

Substrate: Carbon steel
Products: Belzona 1391 (Ceramic HT)

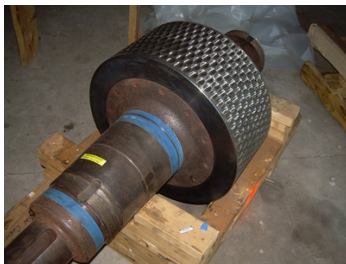
This Briquetter Roll Shaft (with 72 almond pockets) was experiencing pitting corrosion from making salt briquettes.

Damaged area taped off

First, the area is masked off with duct tape especially the machined surfaces are protected against grit blasting and/or accidental contact. The area to be coated is grit blasted with Black Beauty Coal Slag and coated with one coat of Belzona® 1391HT

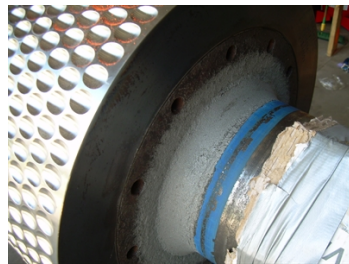
Surface prepped and ready for Belzona product

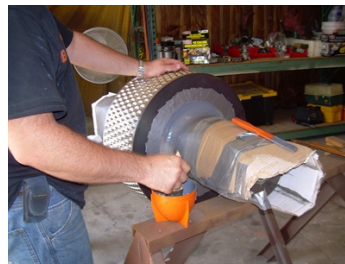
Applying Belzona 1391HT

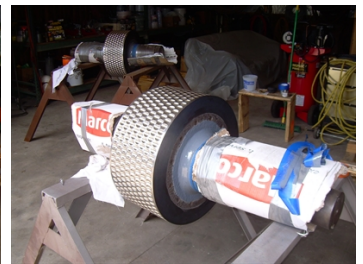
Finished application
