Air Handler Shaft Repair with Belzona 1111

ID: 9841

Application: MPT-Mechanical Power Transmission

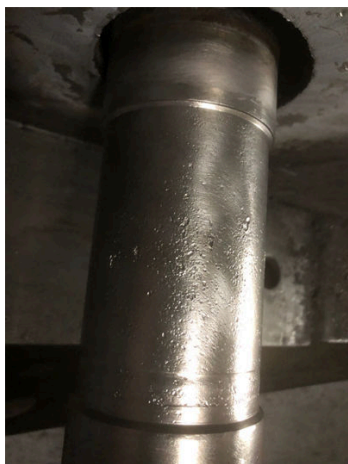
Due to corrosion the shaft was out of balance creating vibration to the air handling unit.

Close up of the pitting corrosion
