Belzona solves special pump protection problem

ID: 9844

Application: ENC-Engines and Casings

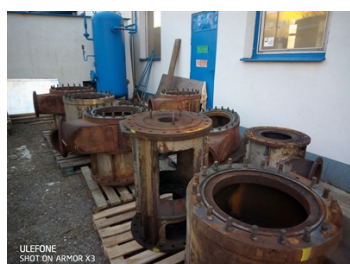
The customer had a long-term problem with this special 6-stage mixing pump in terms of corrosion.

Corrosion damaged equipment

Blasting of individual parts, chemical cleaning, sealing of affected parts with Belzona 4111, application of Belzona 4331 coating, and finally we also implemented an external protective coating.

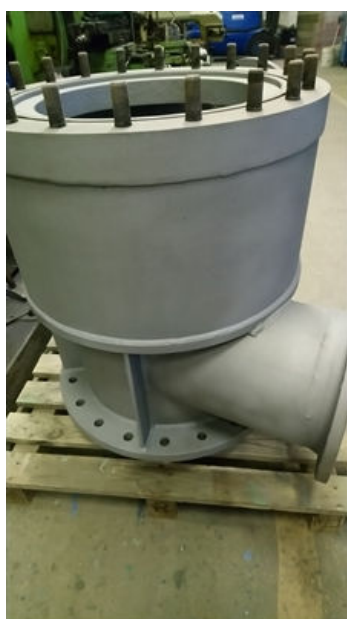
Blasting equipment for Belzona product application

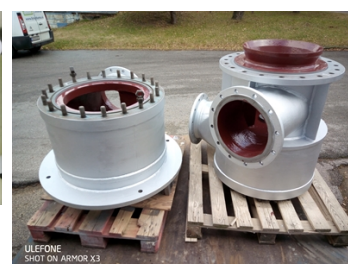
Mixing pump parts before shipment

By applying Belzona products, we have extended the pump's operating cycle several times and increased its efficiency by eliminating pitting corrosion. Thanks to a successful repair, this pump protection is carried out at regular intervals.
