Belzona solves special pump protection problem

ID: 9844

Application: *ENC-Engines and Casings*

Application Date: *August 2023*

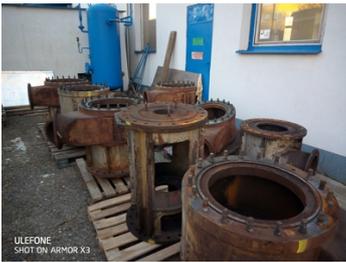
The customer had a long-term problem with this special 6-stage mixing pump in terms of corrosion.

Corrosion damaged equipment

Blasting of individual parts, chemical cleaning, sealing of affected parts with Belzona 4111, application of Belzona 4331 coating, and finally we also implemented an external protective coating.

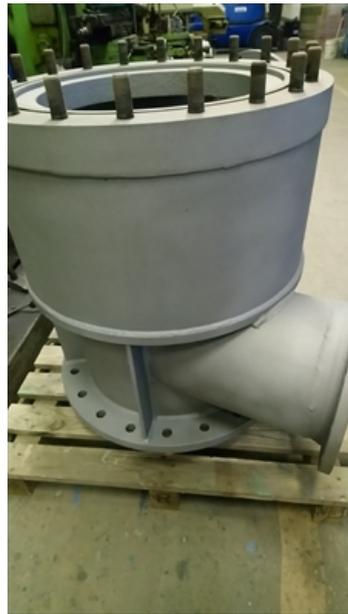
Blasting equipment for Belzona product application

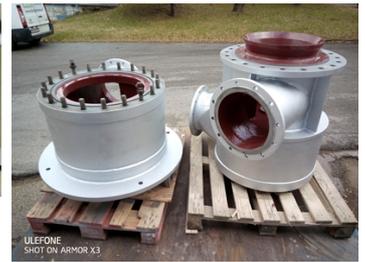
Belzona 4111 was used to fill the pitting corrosion
