Cracked coke gas pipe

ID: 9848

Industry: Steel & Metal Processing

Application: VPF-Valves, Pipes and Fittings

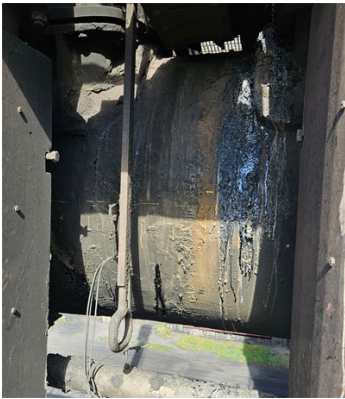
Here we have the area with the crack, tar has leaked out and at the moment the pressure is reduced so no smoke is leaking out

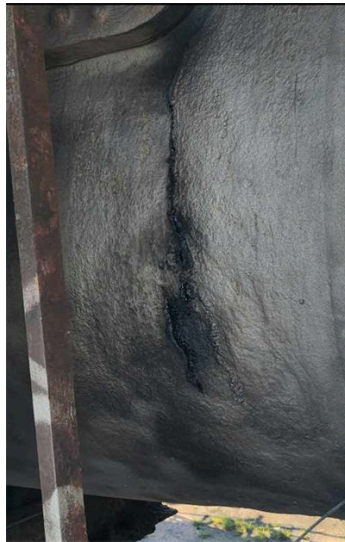
Here the crack is clearly visible after blasting. We have drilled holes at the ends of the crack to minimise the risk of the crack moving on.

Prior to this project, a site visit was made to identify the damage, and to measure what the reinforcement sweep would look like. Once on site, we blasted the area to see the damage in its entirety and drilled holes at the ends of the crack to prevent it from

travelling further. Patched the damage with Belzona 1212. Welded off the area again and the sheet metal sweep. Fitted the sheet metal sweep. Patched the edges with Belzona 1511 to prevent leakage during injection with Belzona 1391T.
